CONDITION REPORT

Report No: 2016858924

Vehicle Type	PASSENGER VEHICLE	Registered Owner	
Manufacturer	NISSAN	Registration Number	JT26KTGP
Model	MICRA ACTIVE 1.2 VISIA NAV 5-DR [2018-2021]	Register Number	
VIN	MDHFBUK13Z0310059	Date Of First Licensing	
Engine Number		Last COR	
Doors	5	License Expiry Date	30/11/2024
Color	SILVER	Power / Displacement	
Year Model	2020	Paint Finish	M - METALLIC
Km Reading	164,529 KM	Fuel	PETROL
Cab / Body Type	HATCHBACK	Transmission	MANUAL

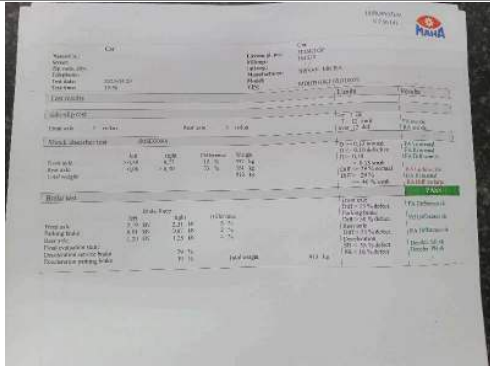
Shock and brake report

Left	Right	Axle Weight [KG]	Deceleration [m/s ²]
	Braking Force [KN]	Braking Force [KN]		
Front	2.1	2.3	-	
Rear	1.3	1.2	-	
Emergency / Parking	0.8	0.8	-

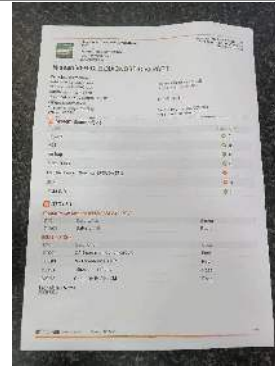
Diagnostic report

No	System	Code	Description	Status
1	PAST	U1000	CAN COMMUNICATION CIRCUIT

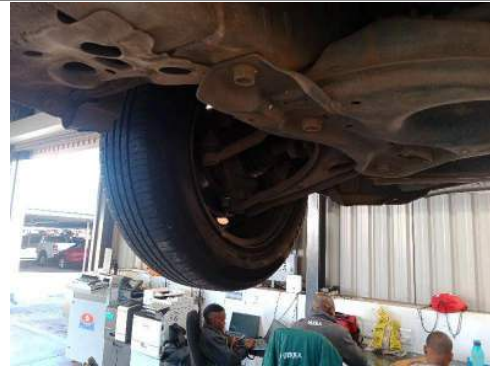
LF TYRE TREAD

Size	Load/Speed Index	Manufacture	Model	Type*	Production Date	Tread Depth (mm)
Front Left	175/65R14	82T	Win run	R330	V	3424	3 mm
Front Right	175/65R14	82T	Win run	R330	V	3424	3 mm
Rear Left	175/65R14	82T	Hankook	Centum	V	4008	0 mm
Rear Right	175/65R14	82T	Zeetex	Zt5000max	V	3622	3 mm

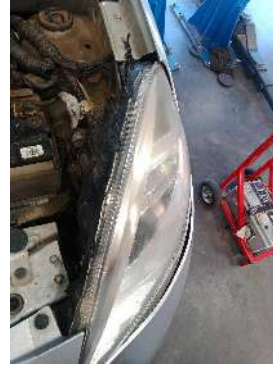
Damage	Repair Way
Indicator Light Front Right Damaged	Repair
Headlight Left Damaged	Replace
Seat Front Right Torn / Cut	Repair
Front Bumper Damaged	Repair
Front Fender Left Dented	Repair
Front Fender Right Paintwork • Scratched	Repair
Rear Fender Left Paintwork • Scratched	Repair
Door Front Left Paintwork • Scratched	Repair
Door Front Right Dented	Repair
Door Rear Left Paintwork • Scratched	Repair
Door Rear Right Paintwork • Scratched	Repair
Boot Lid / Hatch door Dented	Repair
Rear bumper Paintwork • Scratched	Repair
Shock Absorber Rear Left Leak	Replace
Tyre Rear Left Damaged	Replace
Body exterior	Vehicle got some scratches, stone chips and dents
Boot not opening can not see spare wheel	Repair
Body exterior	Signs of spray work done on some body panels
Both front fender liner damage	Replace
