## CONDITION REPORT

Report No:  
2016998150  
DATE  
01/09/2025

| Manufacturer | RENAULT | Registration Number | N/A |
| Model | KWID | Register Number | |

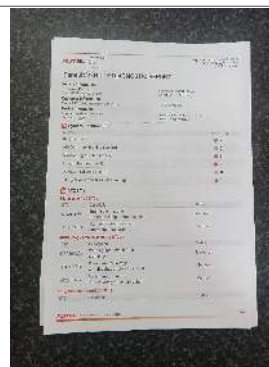
## Shock and brake report

Brakes

Brake Test Results

| | Left | Right | Axle Weight [KG] | Deceleration [m/s <sup>2</sup> ] |
| | Braking Force [KN] | Braking Force [KN] | | |
| Front | 1.4 | 1.4 | - | |
| Rear | 1.1 | 1.1 | - | |
| Emergency / Parking | 0.7 | 0.5 | - | |

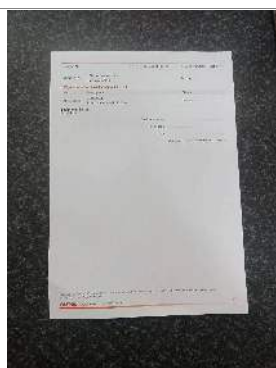
Diagnostic report

During the diagnostic the following error messages were detected: (See also attached Diagnostic Report. For more information regarding the Fault Codes (DTC) and the recommended rectifications please contact the workshops of the vehicle manufacture).

| No | System | Code | Description | Status |
|---|---|---|---|---|
| 1 | MEMORY | DTC903617 | POWER SUPPLY VOLTAGE CIRCUIT VOLTAGE ABOVE THRESHO | |

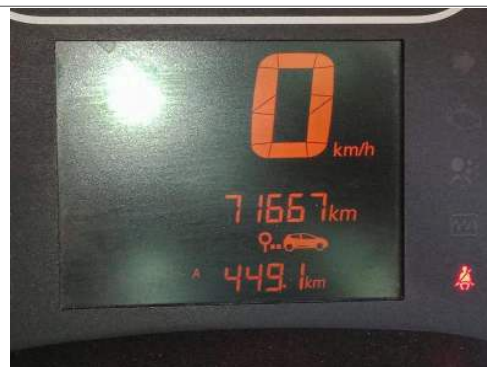
ODOMETER

| Km Reading | 71,667 KM | Fuel | PETROL |

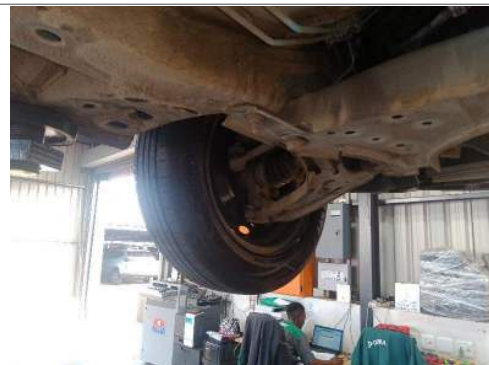
LF TYRE TREAD

| | Size | Load/Speed Index | Manufacture | Model | Type* | Production Date | Tread Depth (mm) |
|---|---|---|---|---|---|---|---|
| Front Left | 165/65R14 | 79H | Westlake | Zupereco | V | 4724 | 3 mm |

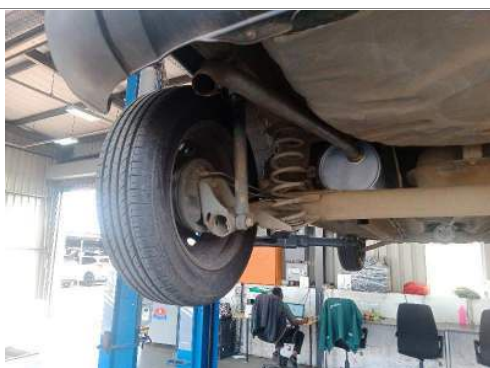
LR TYRE TREAD

| | Size | Load/Speed Index | Manufacture | Model | Type* | Production Date | Tread Depth (mm) |
|---|---|---|---|---|---|---|---|
| Rear Left | 165/65R14 | 79H | Westlake | Zupereco | V | 4724 | 3 mm |

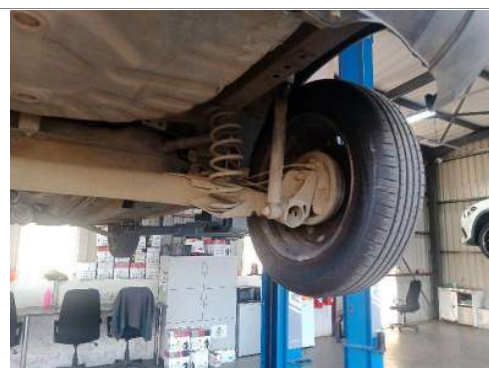
RR TYRE TREAD

| | Size | Load/Speed Index | Manufacture | Model | Type* | Production Date | Tread Depth (mm) |
|---|---|---|---|---|---|---|---|
| Rear Right | 165/65R14 | 79H | Westlake | Zupereco | V | 4724 | 4 mm |

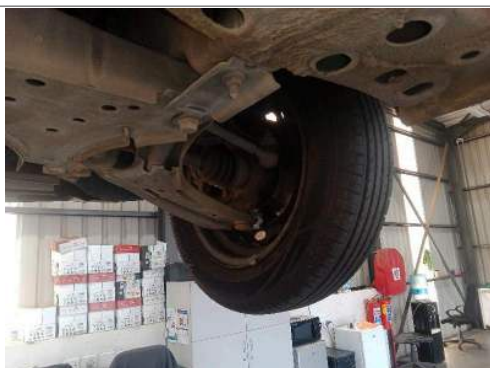
RF TYRE TREAD

| | Size | Load/Speed Index | Manufacture | Model | Type* | Production Date | Tread Depth (mm) |
|---|---|---|---|---|---|---|---|
| Front Right | 165/65R14 | 79H | Westlake | Zupereco | V | 4724 | 3 mm |

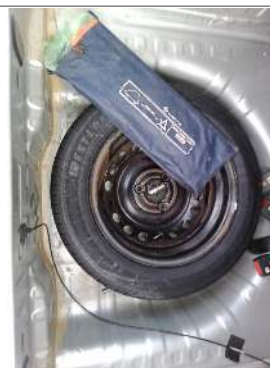
Spare wheel

| | Size | Load/Speed Index | Manufacture | Model | Type* | Production Date | Tread Depth (mm) |
|---|---|---|---|---|---|---|---|
| Spare | 165/65R14 | 79H | Westlake | Zupereco | V | 0000 | 5 mm |

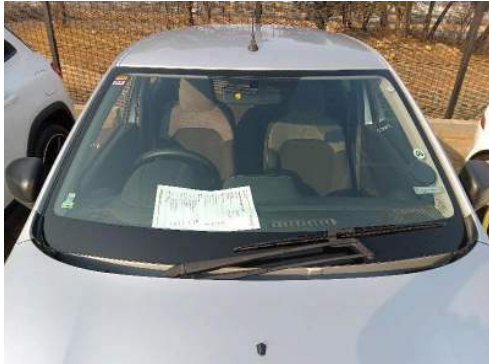
| | Damage | Repair Way |
|---|---|---|
| | Engine Oil Leak<br>Parcel Tray Missing<br>Bonnet Dented<br>Front Fender Left Dented<br>Front Fender Right Dented<br>Door Front Left Dented<br>Door Front Right Dented<br>Door Rear Right Dented<br>Boot Lid / Hatch door Dented<br>Roof Dented<br>No license disc<br>Both number plates missing | Repair<br>Replace<br>Repair<br>Repair<br>Repair<br>Repair<br>Repair<br>Repair<br>Repair<br>Repair<br>Replace<br>Replace |

No license disc
