## CONDITION REPORT

Report No:  
2016996137  
DATE  
29/08/2025

| Manufacturer | RENAULT | Registration Number | LL41RBGP |
| Model | KIGER | Register Number | |

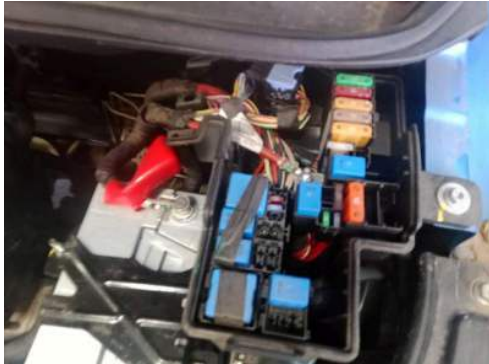
Fuse box cover missing

| | Damage | Repair Way |
|--|---|---|
| | Fuse box cover missing | Repair |

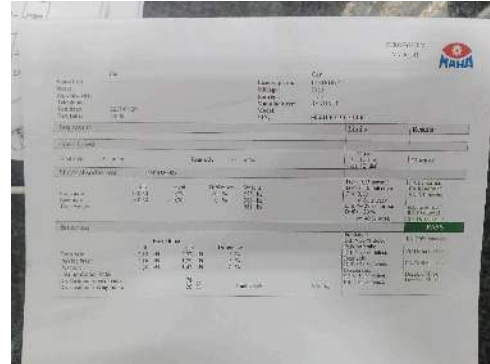
Shock and brake report

Brakes  
Brake Test Results

| | Left | Right | | |
|---|---|---|---|---|
| Front | 2.1 | 2.3 | - | |
| Rear | 1.3 | 1.4 | - | |
| Emergency / Parking | 1.1 | 1.2 | - | |

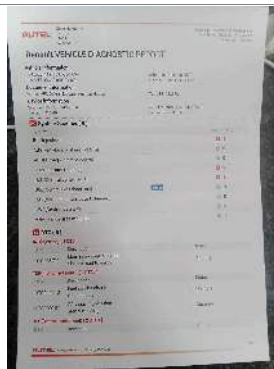
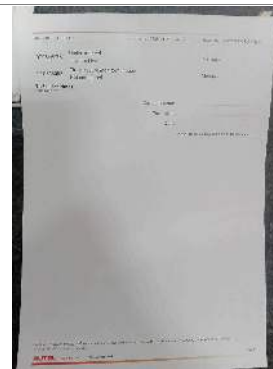
Diagnostic test

During the diagnostic the following error messages were detected: (See also attached Diagnostic Report. For more information regarding the Fault Codes (DTC) and the recommended rectifications please contact the workshops of the vehicle manufacture).

| No | System | Code | Description | Status |
|---|---|---|---|---|
| 1 | INJECTION | DTC065711 | MAIN RELAY CONTROL CIRCUIT SHORT CIRCUIT TO EARTH | |

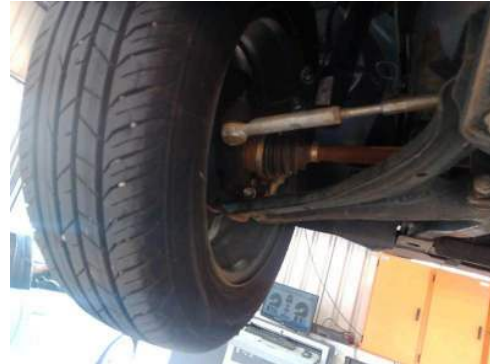
LF TYRE TREAD

| | Size | Load/Speed Index | Manufacture | Model | Type* | Production Date | Tread Depth (mm) |
|---|---|---|---|---|---|---|---|
| Front Left | 195/60R16 | 89V | Ceat | Securadrive | V | 2521 | 5 mm |

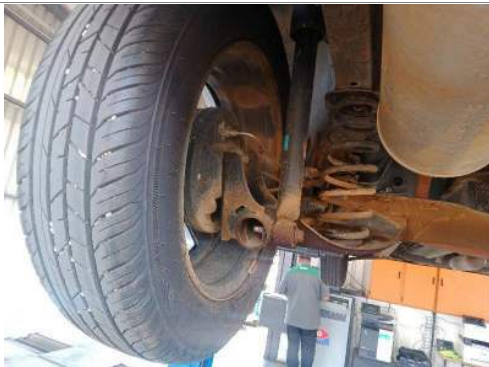
LR TYRE TREAD

| | Size | Load/Speed Index | Manufacture | Model | Type* | Production Date | Tread Depth (mm) |
|---|---|---|---|---|---|---|---|
| Rear Left | 195/60R16 | 89V | Ceat | Securadrive | V | 2521 | 6 mm |

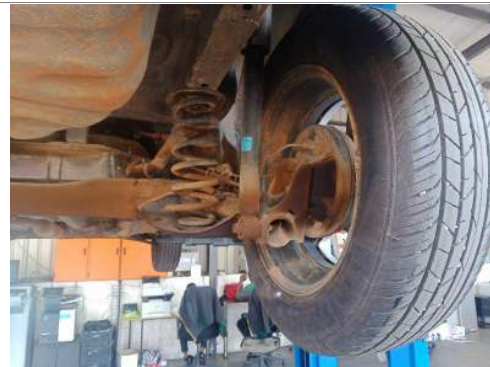
RR TYRE TREAD

| | Size | Load/Speed Index | Manufacture | Model | Type* | Production Date | Tread Depth (mm) |
|---|---|---|---|---|---|---|---|
| Rear Right | 195/60R16 | 89V | Ceat | Securadrive | V | 2523 | 6 mm |

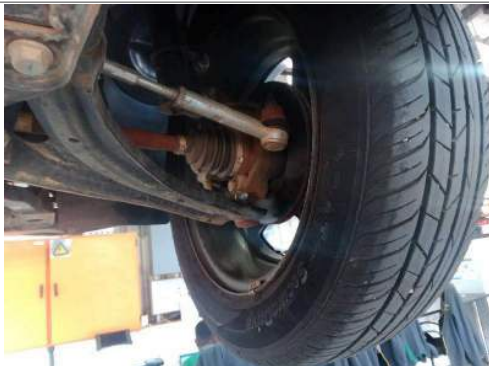
RF TYRE TREAD

| | Size | Load/Speed Index | Manufacture | Model | Type* | Production Date | Tread Depth (mm) |
|---|---|---|---|---|---|---|---|
| Front Right | 195/60R16 | 89V | Ceat | Secura drive | V | 2523 | 6 mm |

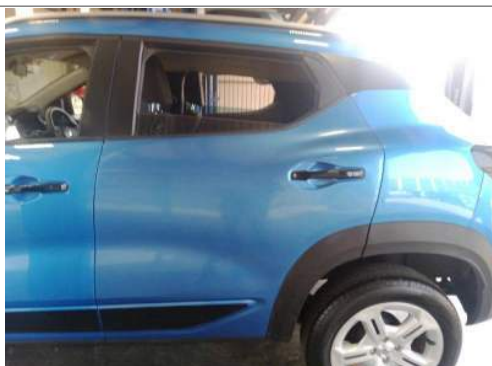
| | Damage | Repair Way |
|--|---|---|
| | Door Rear Left Residual Traces of Repair | Repair |

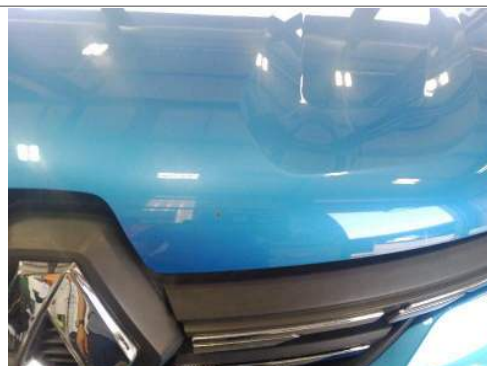
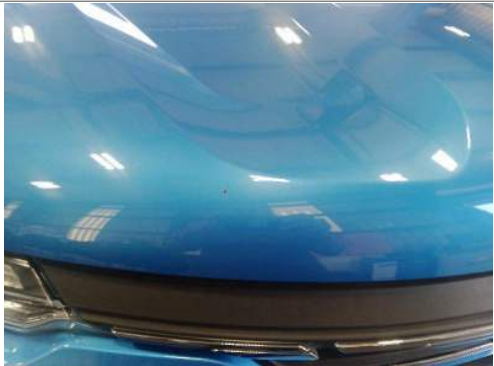
| | Damage | Repair Way |
|--|---|---|
| | Bonnet Paintwork • Chipmarks | Repair |
