## CONDITION REPORT

Report No: 2016416853

Vehicle Type	PASSENGER VEHICLE	Registered Owner	MFC AUCTION HOUSE
Manufacturer	TOYOTA	Registration Number	NN17896
Model	AVANZA	Register Number	
VIN	MHKM1CA2NBK008171	Date Of First Licensing	
Engine Number		Last COR	
Doors	5	License Expiry Date	30/04/2025
Color	WHITE	Power / Displacement	
Year Model		Paint Finish	C - COMMON
Km Reading	121,014 KM	Fuel	PETROL
Cab / Body Type	HATCHBACK	Transmission	MANUAL

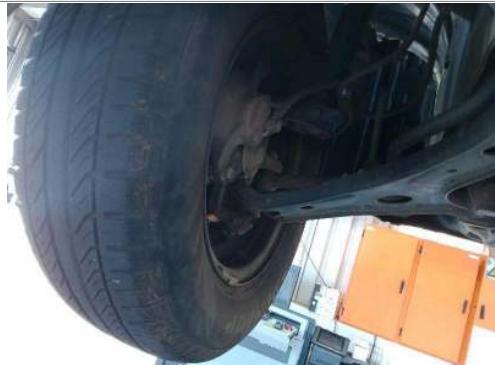
LF TYRE TREAD

Size	Load/Speed Index	Manufacture	Model	Type*	Production Date	Tread Depth (mm)
Front Left	185/70R14	88T	Dunlop	Sport	V	4920	2 mm
Front Right	185/70R14	88T	Dunlop	Sport	V	4920	1 mm
Rear Left	185/70R14	88T	Dunlop	Sport	V	4920	3 mm
Rear Right	185/70R14	88T	Dunlop	Sport	V	4920	3 mm
Spare	185/70R14	88S	Dunlop	Sport	V	0000	5 mm

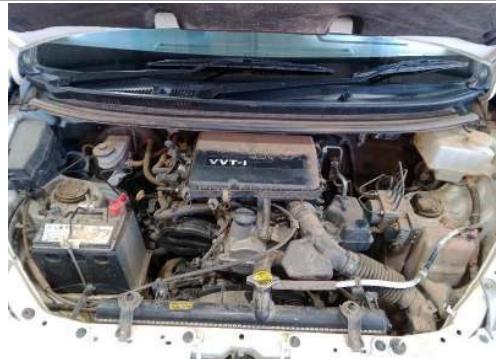
ENGINE 1

Engine number – not possible to verify engine number (not visible without dismantling)

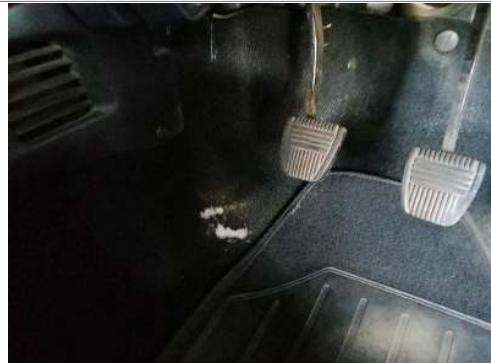
Damage	Repair Way
Seat Rear Torn / Cut	Repair
Hood Lining Excessive Wear & Tear	Repair
Dash Padding Damaged	Repair
Carpet Front Torn / Cut	Replace
Carpet Rear Excessive Wear & Tear	Repair
Bonnet Paintwork • Scratched	Repair
Rear bumper Paintwork • Scratched	Repair
Stabilizer Mounting Front Left Damaged	Replace
Stabilizer Mounting Front Right Damaged	Replace
Trailing Arm Rear Axle Right Damaged	Replace
Body exterior	Signs of spray work done on some body panels
Engine.	Bottom of engine is fully covered
