CONDITION REPORT

Report No: 2016250561

MFC Auction House
M57 Pretoria Rd, Glenmarais, KEMPTON PARK
Gauteng

Vehicle Type	PASSENGER VEHICLE	Registered Owner	MFC AUCTION HOUSE
Manufacturer	NISSAN	Registration Number	HN81JFGP
Model	QASHQAI	Register Number	
VIN	SJNFAAJ11Z2191790	Date Of First Licensing	
Engine Number		Last COR	
Doors	5	License Expiry Date	31/08/2023
Color	GREY	Power / Displacement	
Year Model		Paint Finish	TWO COAT METALLIC
Km Reading	203,653 KM	Fuel	PETROL
Cab / Body Type	HATCHBACK	Transmission	MANUAL

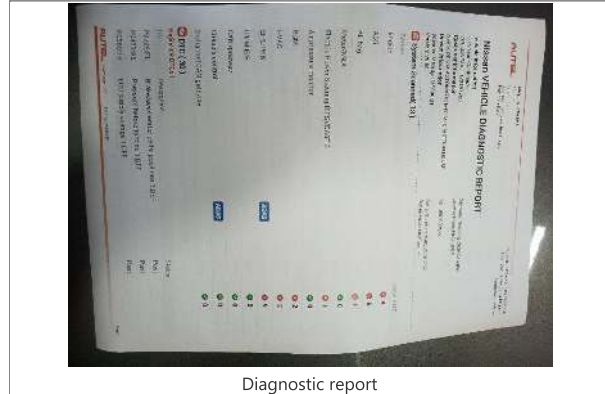
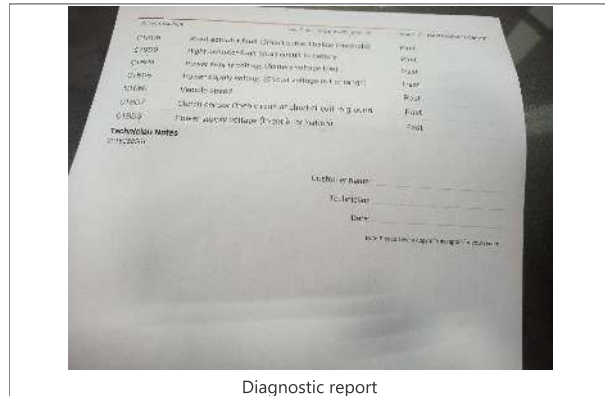
Diagnostic report

During the diagnostic no active error messages were detected. (See also attached Diagnostic Report. For more information regarding the Fault Codes (DTC) and the recommended rectifications please contact the workshops of the vehicle manufacture).

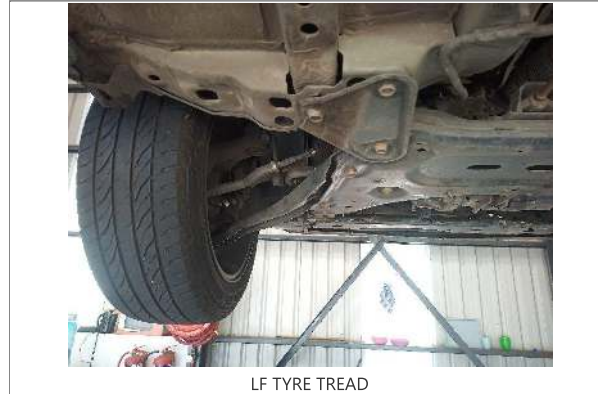
LF TYRE TREAD

Size	Load/Speed Index	Manufacture	Model	Type*	Production Date	Tread Depth (mm)
Front Left	215/55R18	99V	Lanvigator	Radial	V	2622	2 mm
Front Right	215/55R18	99V	Lanvigator	Radial	V	2622	3 mm
Rear Left	215/55R18	99V	Lanvigator	Radial	V	2922	4 mm
Rear Right	215/55R18	99V	lanvigator	Radial	V	2622	4 mm

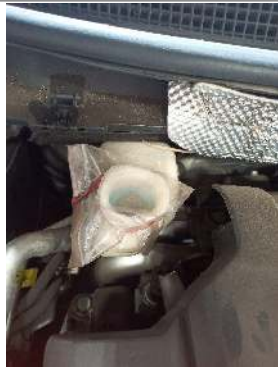
Damage	Repair Way
Caps Missing	Replace
Front Bumper Damaged	Repair
Bonnet Damaged	Repair
Front Fender Left Damaged	Repair
Front Fender Right Damaged	Repair
Rear Fender Left Damaged	Repair
Rear Fender Right Damaged	Repair
Door Front Left Damaged	Repair
Door Front Right Damaged	Repair
Door Rear Left Damaged	Repair
Door Rear Right Damaged	Repair
Rear bumper Damaged	Repair
Windscreen Damaged	Replace
