CONDITION REPORT

Report No: 2016883076

DATE  
19/05/2025

Vehicle Type	PASSENGER VEHICLE	Registered Owner	
Manufacturer	AUDI	Registration Number	LS87DDGP
Model	S3 SEDAN 213KW QUATTRO S TRONIC [2022-2024]	Register Number	
VIN	WAUZZZGY0PA029108	Date Of First Licensing	
Engine Number		Last COR	
Doors	4	License Expiry Date	30/04/2025
Color	YELLOW	Power / Displacement	
Year Model	2023	Paint Finish	C - COMMON
Km Reading	58,525 KM	Fuel	PETROL
Cab / Body Type	SEDAN	Transmission	AUTOMATIC

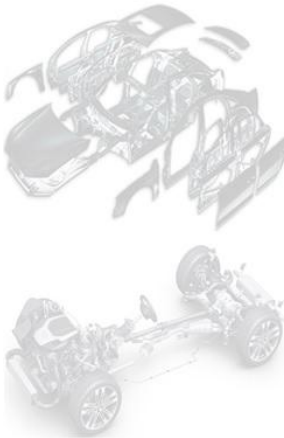
Damage	Repair Way
Front Bumper Paintwork • Scratched	Repair
Front Fender Right Paintwork • Scratched	Repair
Rear Fender Left Paintwork • Scratched	Repair
Rear Fender Right Dented	Repair
Door Front Right Paintwork • Scratched	Repair
Tyre Front Left Damaged	Repair
Body exterior	Vehicle got minor scratches, stone chips and dents
Brakes	No brake test done vehicle is 4wd

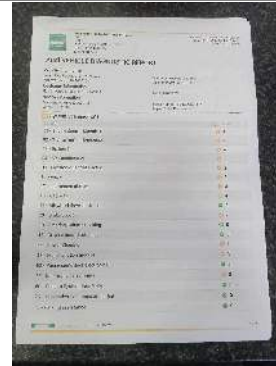
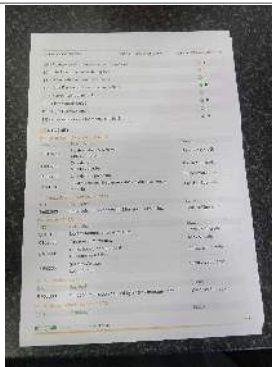
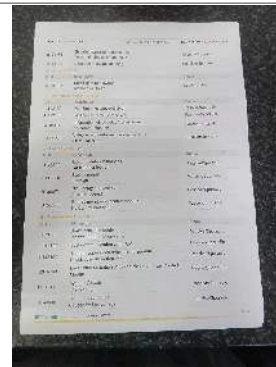
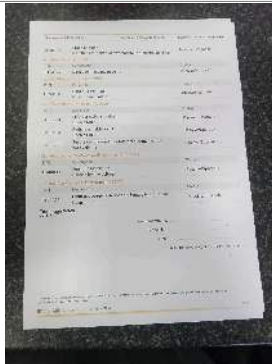
Diagnostic report

No	System	Code	Description	Status
1	ACTIVE/ STATIC	B101C07	DRIVER SEAT BELT SWITCH MECHANICAL FAULT

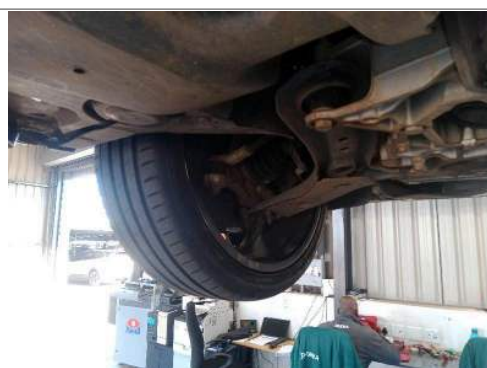
LF TYRE TREAD

Size	Load/Speed Index	Manufacture	Model	Type*	Production Date	Tread Depth (mm)
Front Left	235/35R19	91Y	Apollo	Aspire	V	1323	4 mm
Front Right	235/35R19	91Y	Apollo	Aspire	V	2923	4 mm
Rear Left	235/35R19	91Y	Apollo	Aspire	V	1323	4 mm
Rear Right	235/35R19	91Y	Apollo	Aspire	V	2923	4 mm
Spare	T125/70R18	99M	Ling long	Temporary	V	0000	2 mm
