## CONDITION REPORT

Report No:  
2016984283  
DATE  
19/08/2025

| Manufacturer | MERCEDES-BENZ | Registration Number | JH82MJGP |
| Model | VITO | Register Number | |

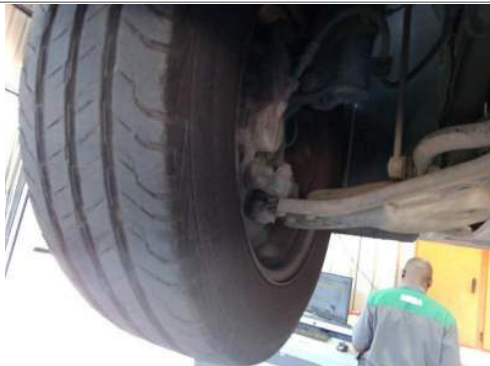
LF TYRE TREAD

| | Size | Load/Speed Index | Manufacture | Model | Type* | Production Date | Tread Depth (mm) |
|---|---|---|---|---|---|---|---|
| Front Left | 205/65R16 | 107/105T | Continental | Contact | V | 4223 | 2 mm |

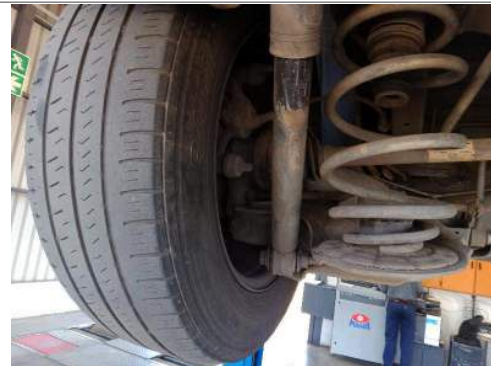
LR TYRE TREAD

| | Size | Load/Speed Index | Manufacture | Model | Type* | Production Date | Tread Depth (mm) |
|---|---|---|---|---|---|---|---|
| Rear Left | 205/65R16 | 107/105T | Hankook | Radial | V | 5124 | 1 mm |

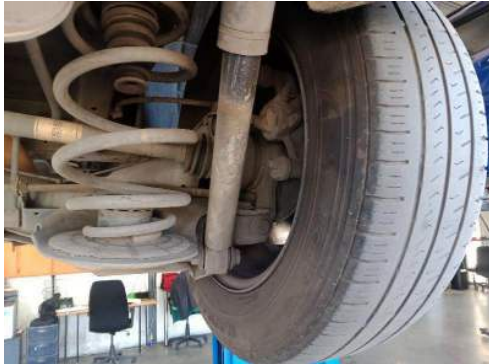
RR TYRE TREAD

| | Size | Load/Speed Index | Manufacture | Model | Type* | Production Date | Tread Depth (mm) |
|---|---|---|---|---|---|---|---|
| Rear Right | 205/65R16 | 107/105T | Hankook | Radial | V | 5121 | 3 mm |

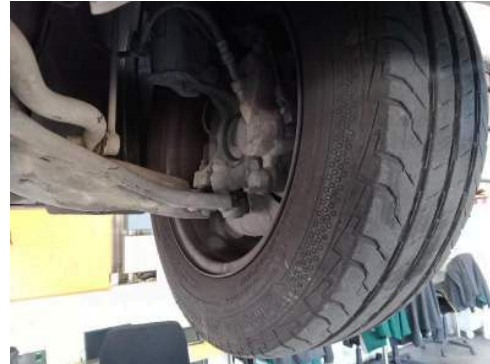
RF TYRE TREAD

| | Size | Load/Speed Index | Manufacture | Model | Type* | Production Date | Tread Depth (mm) |
|---|---|---|---|---|---|---|---|
| Front Right | 205/65R16 | 107/105T | Continental | Contact | V | 4223 | 2 mm |

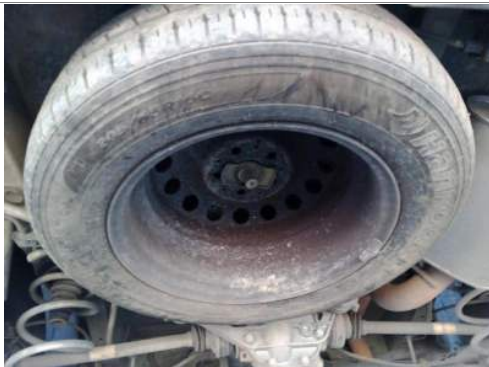
Sparewheel

| | Size | Load/Speed Index | Manufacture | Model | Type* | Production Date | Tread Depth (mm) |
|---|---|---|---|---|---|---|---|
| Spare | 205/65R16 | 107/105T | Hankook | Radial | V | //////// | 2 mm |

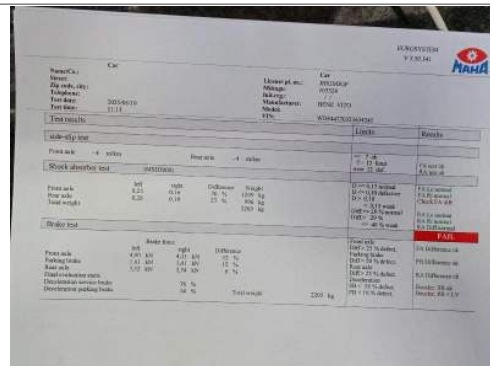
SHOCK AND BRAKE REPORT

| | Left | Right | Axle Weight [KG] | Deceleration [m/s²] |
|---|---|---|---|---|
| Front | 4.9 | 4.3 | - | |
| Rear | 3.5 | 3.7 | - | |
| Emergency / Parking | 1.6 | 1.4 | - | |

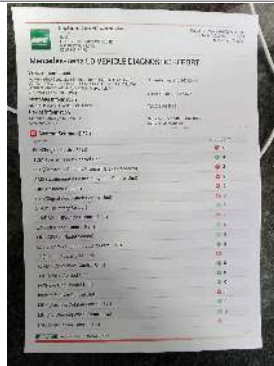
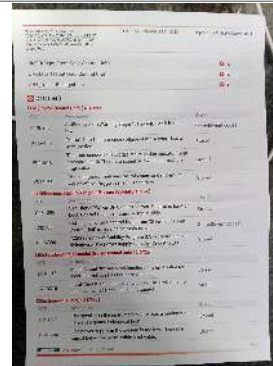
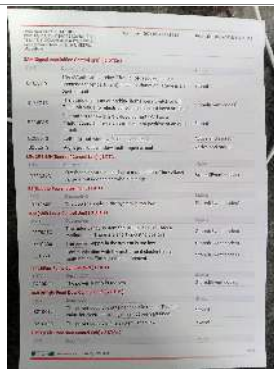
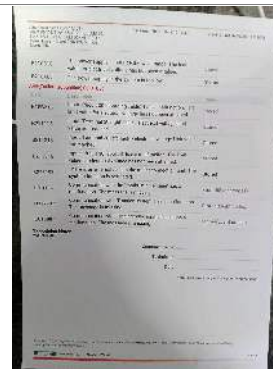
DIAGNOSTIC REPORT PAGE 1

| No | System | Code | Description | Status |
|---|---|---|---|---|
| 1 | SIGNAL ACQUISITION<br>CONTROL UNIT | B25E613 | RIGHT POP OUT WINDOW FAULT OPEN CIRCUIT | |
