CONDITION REPORT

Report No: 2016230764

Vehicle Type	PASSENGER VEHICLE	Registered Owner	MFC AUCTION HOUSE
Manufacturer	VOLKSWAGEN	Registration Number	LB91ZTGP
Model	TIGUAN	Register Number	
VIN	WVGZZZ5NZJW980511	Date Of First Licensing	
Engine Number		Last COR	
Doors	5	License Expiry Date	29/02/2024
Color	SILVER	Power / Displacement	
Year Model		Paint Finish	TWO COAT METALLIC
Km Reading	136,277 KM	Fuel	PETROL
Cab / Body Type	STATION WAGON	Transmission	AUTOMATIC

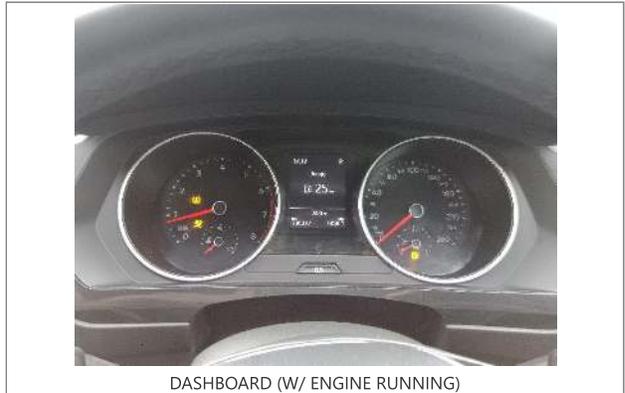
General Comments: AIRBAG AND TYRE PRESSURE WARNING LIGHTS ILLUMINATED ON DASHBOARD.Engine Compartment: Engine bay dirty.Brake fluid level ok.Oil sweat on brake booster reservoir.  
Interior: Vehicle interior dirty and some interior panels scratched.  
Body • Ext

DASHBOARD (W/ ENGINE RUNNING)

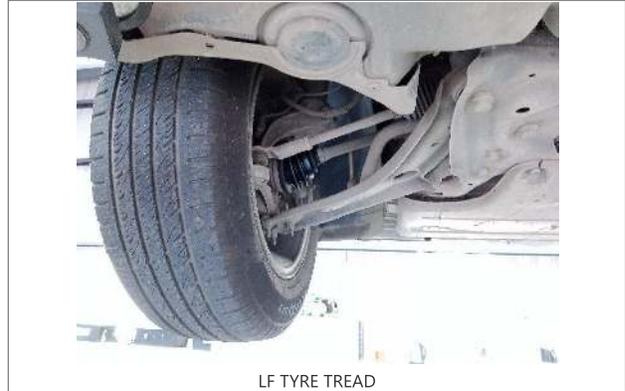
LF TYRE TREAD

Size	Load/Speed Index	Manufacture	Model	Type*	Production Date	Tread Depth (mm)
Front Left	215/65 R17	99H	Royalblack	Sport	V	3322	4 mm
Front Right	215/65 R17	99H	Royalblack	Sport	V	3322	4 mm
Rear Left	215/65 R17	99H	Royalblack	Sport	V	3222	5 mm
Rear Right	215/65 R17	99H	Royalblack	Sport	V	3322	5 mm
Spare	215/65 R17	99V	Falken	Ziex	V		0 mm

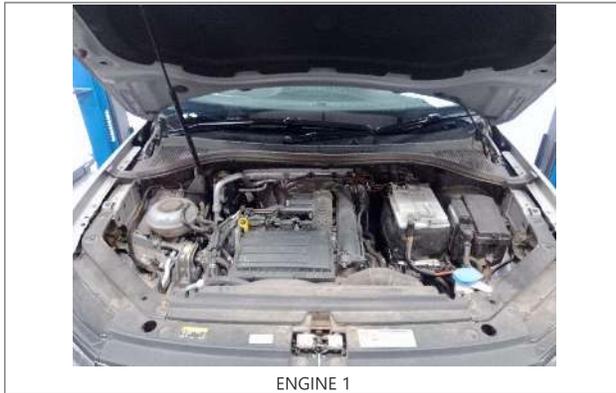
ENGINE 1

Damage	Repair Way
Engine Oil Sweat	Repair
Bonnet stay and shocks Defective	Replace
Windscreen Wiper Damaged	Replace
Headlight Left Scratched	Replace
Seat Front Left Dirty	Repair
Seat Front Right Defective	Repair
Seat Rear Defective	Repair
Hood Lining Dirty	Repair
Steering Wheel Trim Defective	Repair
Side Mirror Left Paintwork • Scratched	Repair
Front Bumper Damaged	Repair
Bonnet Paintwork • Chipmarks	Repair
C • Pillar Left Dented	Repair
C • Pillar Right Dented	Repair
Front Fender Left Damaged	Repair
Rear Fender Left Dented	Repair
Rear Fender Right Paintwork • Scratched	Repair
Door Front Left Dented	Repair
Door Front Right Residual Traces of Repair	Repair
Door Rear Left Dented	Repair
Door Rear Right Residual Traces of Repair	Repair
Boot Lid / Hatch door Paintwork • Scratched	Repair
Rear bumper Paintwork • Scratched	Repair
Sill Panel Right Paintwork • Scratched	Repair
Windscreen Cracked	Replace
Shock Absorber Front Right Sweat	Replace

Spare Tyre Worn	Replace
Belly plates Damaged	Replace
Engine Noise Excessive	Repair
