CONDITION REPORT

Report No: 2016221731

Vehicle Type	PASSENGER VEHICLE	Registered Owner	MFC
Manufacturer	VOLKSWAGEN	Registration Number	HM50HKGP
Model	JETTA TSI	Register Number	
VIN	WVWZZZ16ZHM000572	Date Of First Licensing	
Engine Number		Last COR	
Doors	4	License Expiry Date	31/08/2024
Color	BLUE	Power / Displacement	
Year Model		Paint Finish	M - METALLIC
Km Reading	166,739 KM	Fuel	PETROL
Cab / Body Type	SEDAN	Transmission	AUTOMATIC

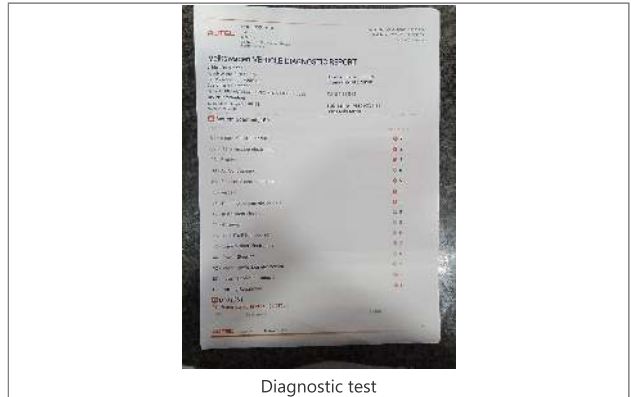
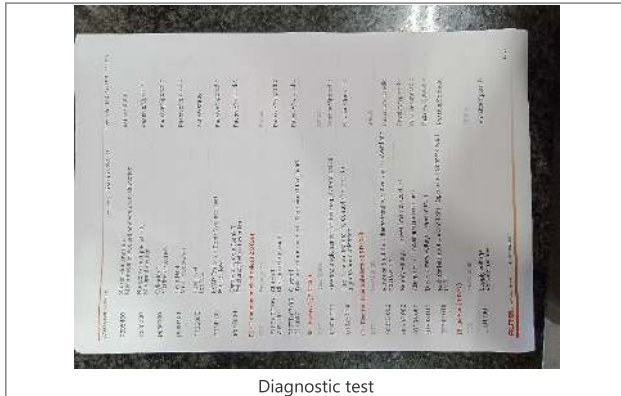
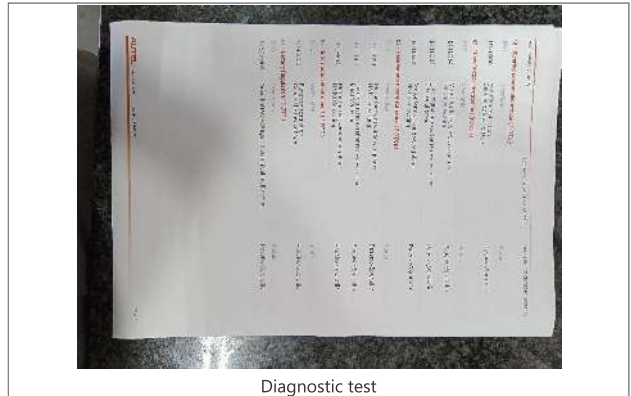
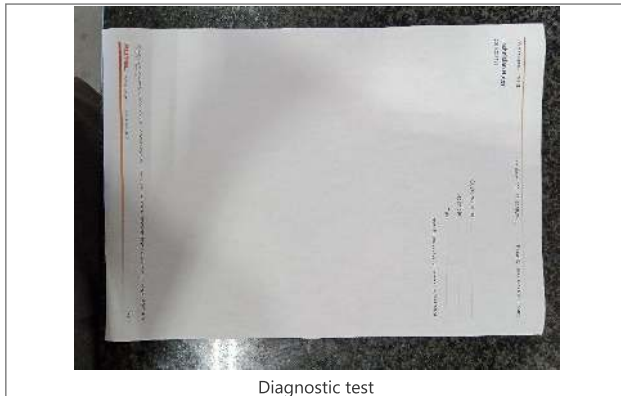
Diagnostic test

No	System	Code	Description	Status
1	ENGINE CONTROL MODULE	P305400	STARTER DOES NOT TURN MECHANICALLY BLOCKED OR ELEC

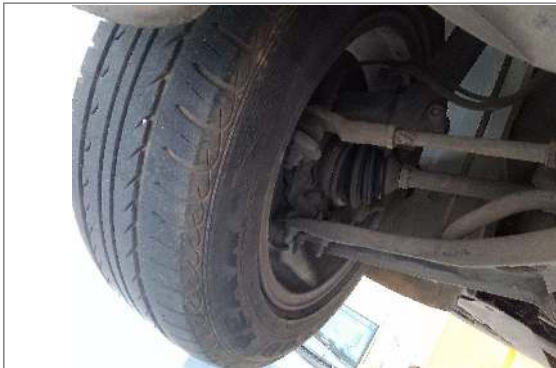
LF TYRE TREAD

Size	Load/Speed Index	Manufacture	Model	Type*	Production Date	Tread Depth (mm)
Front Left	205/55R16	91W	Goodyear	Efficient	V		2 mm
Front Right	205/55R16	91W	Goodyear	Efficient	V	4120	2 mm
Rear Left	205/55R16	91W	Goodyear	Efficient	V	2420	6 mm
Rear Right	205/55R16	91V	Hankook	Ventus	V	1516	5 mm
Spare	205/55R16	91W	Goodyear	Efficient	V	///////	5 mm

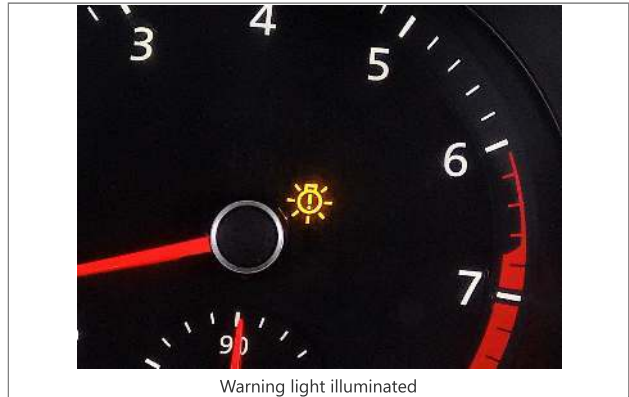
Damage	Repair Way
Indicator Light Front Right Broken	Repair
Rear Lower Valance Damaged	Repair
Front Bumper Paintwork • Scratched	Repair
Front Fender Right Damaged	Repair
Rear Fender Right Dented	Repair
Door Front Left Dented	Repair
Door Rear Right Dented	Repair
Rear bumper Cracked	Repair
Tyre Front Right Excessive Wear & Tear	Replace
Gearbox Oil Leak	Repair
Warning light illuminated	Repair
