CONDITION REPORT

Report No:
2017305357
DATE
30/09/2026

Vehicle Type	PASSENGER VEHICLE	Registered Owner	MFC
Manufacturer	VOLKSWAGEN	Registration Number	FS16RDGP
Model	POLO GP 1.2 TSI HIGHLINE 81KW 5-DR [2015-2017]	Register Number	
		Date Of First Licensing	
VIN	AAVZZZ6RZGU019119	Last COR	
Engine Number		License Expiry Date	31/01/2021
Doors	5	Power / Displacement	
Color	RED	Paint Finish	TWO COAT UNI
Year Model	2015	Fuel	PETROL
Km Reading	162,136 KM	Transmission	MANUAL
Cab / Body Type	HATCHBACK

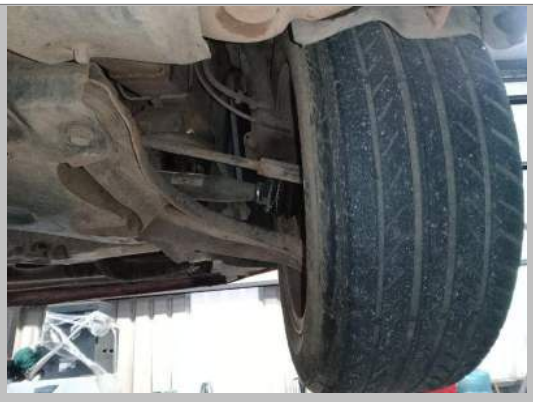
RF TYRE TREAD

Size	Load/Speed Index	Manufacture	Model	Type*	Production Date	Tread Depth (mm)
Front Left	215/45Z R16	90W	Davanti	DX390	V	1521	3 mm
Front Right	205/55 R16	91W	Velocity	Axe	V	3715	0 mm
Rear Left	185/60 R15	84H	Continental	Contipremuim	V	0415	5 mm
Rear Right	215/45 R16	86V	Dunlop	Sp-Sport	V	4617	1 mm

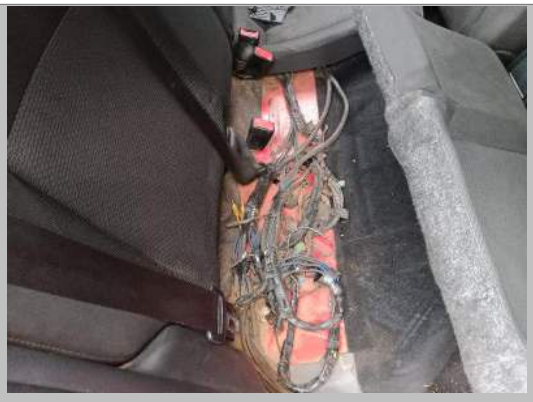
Damage	Repair Way
Gear Selections Malfunction	Repair
Warning lights illuminated on dashboard	Repair
Loose sound wiring inside boot of vehicle	Replace
Front right shock absorber weak	Replace
Front and rear tyre sizes different	Repair
Signs of vehicle overheating	Repair
Front wiper motor not working	Replace

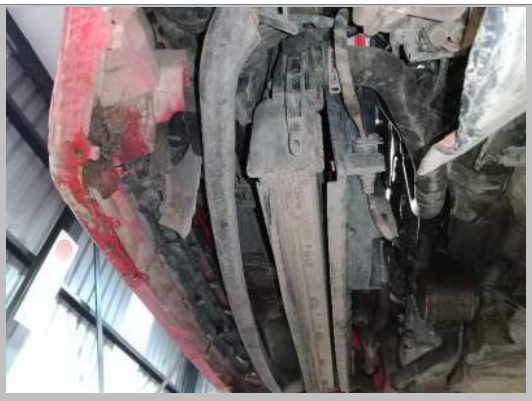
Belly plates Damaged	Replace
Gearbox Oil Leak	Repair
CV Joint(s) Front Right (inner/outer) Defective	Repair
Radiator Cradle Damaged	Replace
Steering Loose / Excessive Play	Repair
