# CONDITION REPORT

**Report No:**
**2017323388**
**DATE**
**09/11/2026**

| Manufacturer | VOLKSWAGEN | Registration Number | KH22LGGP |
| Model | POLO VIVO 1.6 COMFORTLINE 5-DR TIPTRONIC [2021-2023] | Register Number | |

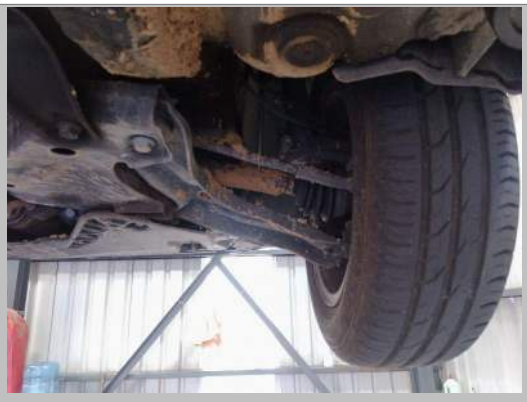
RF TYRE TREAD

| | Size | Load/Speed Index | Manufacture | Model | Type* | Production Date | Tread Depth (mm) |
|---|---|---|---|---|---|---|---|
| **Front Right** | 185/60R15 | 84H | Continental | Contipremiu | V | 2823 | 2 mm |
