CONDITION REPORT

Report No:
2016978074
DATE
13/08/2025

Vehicle Type	**PASSENGER VEHICLE**	Registered Owner	**MFC**
Manufacturer	**VOLKSWAGEN**	Registration Number	**JYW135MP**
Model	**POLO VIVO GP 1.4 CONCEPTLINE 5-DR [2014-2016]**	Register Number	
		Date Of First Licensing	
VIN	**AAVZZZ6SZFU032849**	Last COR	
Engine Number		License Expiry Date	**30/04/2024**
Doors	**5**	Power / Displacement	
Color	**WHITE**	Paint Finish	**TWO COAT UNI**
Year Model	**2015**	Fuel	**PETROL**
Km Reading	**452,129 KM**	Transmission	**MANUAL**
Cab / Body Type	**HATCHBACK**

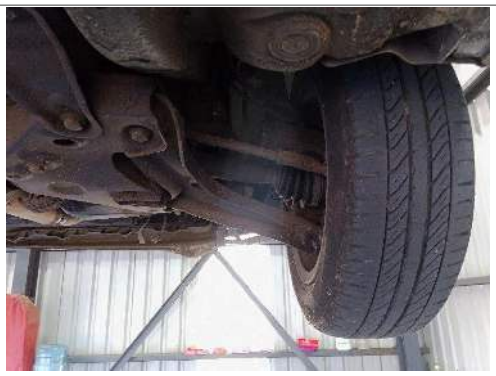
RR TYRE TREAD

Size	Load/Speed Index	Manufacture	Model	Type*	Production Date	Tread Depth (mm)
Front Left	175/65R14	82H	Goodride	Radial	V	1613	0 mm
Front Right	175/65R14	82T	Dunlop	Sp	V	4122	0 mm
Rear Left	185/60R14	82H	Royal black	Radial	V	1822	2 mm
Rear Right	175/65R14	82H	Westlake	Radial	V	3521	0 mm

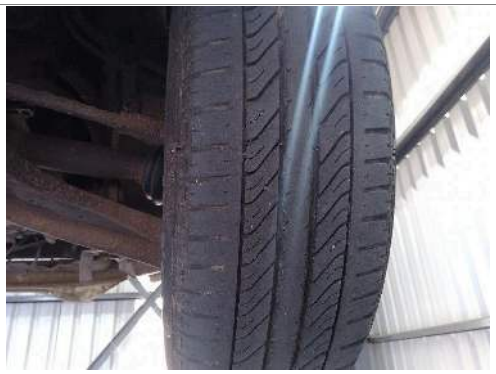
Tyre Rear Left

General Comments: ACCORDING TO THE AGE AND MILEAGE OF THE VEHICLE, NORMAL WEAR AND TEAR MARKS ARE VISIBLE ON THE INTERIOR, EXTERIOR, ELECTRICAL AND MECHANICAL PARTS.Engine Compartment: Battery loose. sump damaged.
Tyres and Rims: left rear tire has a flat spot.
