CONDITION REPORT

Report No:
2017322502
DATE
06/11/2026

Vehicle Type	PASSENGER VEHICLE	Registered Owner	MFC AUCTION HOUSE
Manufacturer	VOLKSWAGEN	Registration Number	
Model	POLO 1.0 TSI 70KW LIFE 5-DR [2023-2025]	Register Number	
VIN	AAVZZZAWXRU041350	Date Of First Licensing	
Engine Number		Last COR	
Doors	5	License Expiry Date	31/03/2025
Color	BEIGE	Power / Displacement	
Year Model	2024	Paint Finish	TWO COAT UNI
Km Reading	35,360 KM	Fuel	PETROL
Cab / Body Type	HATCHBACK	Transmission	MANUAL

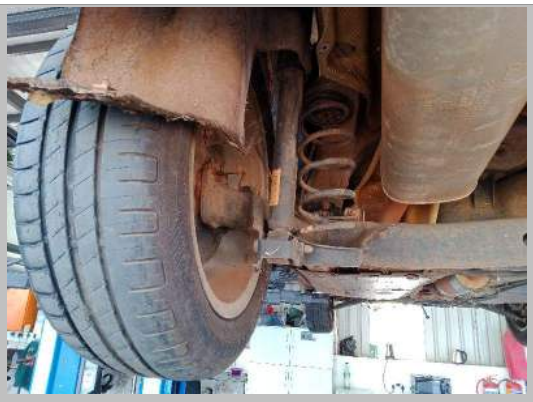
LR TYRE TREAD

Size	Load/Speed Index	Manufacture	Model	Type*	Production Date	Tread Depth (mm)
Front Left	185/60 R15	84H	Winrun	R330	V	2624	0 mm
Front Right	185/65 R15	92T	Dunlop	Sp-Touring	V	2224	1 mm
Rear Left	185/60 R15	88H	Goodyear	Efficient	V	0619	4 mm
Rear Right	185/60 R15	84H	Continental	Contipremuim	V	2716	2 mm
