CONDITION REPORT

Report No:
2017293883
DATE
03/09/2026

Vehicle Type	LIGHT LOAD VEHICLE	Registered Owner	MFC
Manufacturer	ISUZU	Registration Number	KXN963MP
Model	D-MAX 1.9 DDI HR L DSL PU AT [2022-2023]	Register Number	
VIN	ACVTFR87JMD135626	Date Of First Licensing	
Engine Number		Last COR	
Doors	2	License Expiry Date	
Color	WHITE	Power / Displacement	
Year Model	2023	Paint Finish	C - COMMON
Km Reading	55,147 KM	Fuel	DIESEL
Cab / Body Type	SINGLE CAB	Transmission	AUTOMATIC

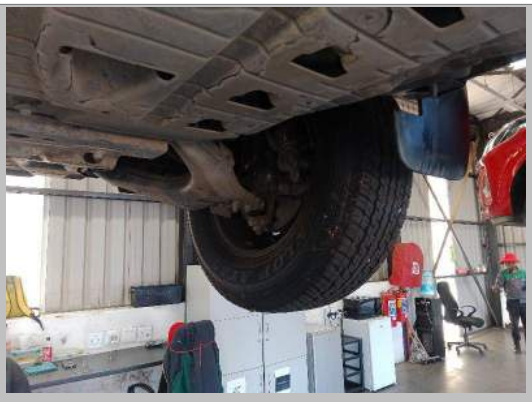
LF TYRE TREAD

Size	Load/Speed Index	Manufacture	Model	Type*	Production Date	Tread Depth (mm)
Front Left	255/65R17	110H	Dunlop	Grandtrek	V	1924	4 mm
Front Right	255/65R17	110H	Dunlop	Grandtrek	V	0224	4 mm
Rear Left	255/65R17	110H	Dunlop	Grandtrek	V	4322	4 mm
Rear Right	255/65R17	110H	Dunlop	Grandtrek	V	4322	2 mm
Spare	255/65R17	110H	Dunlop	Grandtrek	V	0000	4 mm

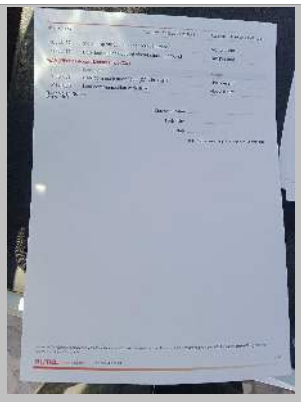
DIAGNOSTIC REPORT

During the diagnostic the following error messages were detected: (See also attached Diagnostic Report. For more information regarding the Fault Codes (DTC) and the recommended rectifications please contact the workshops of the vehicle manufacture).

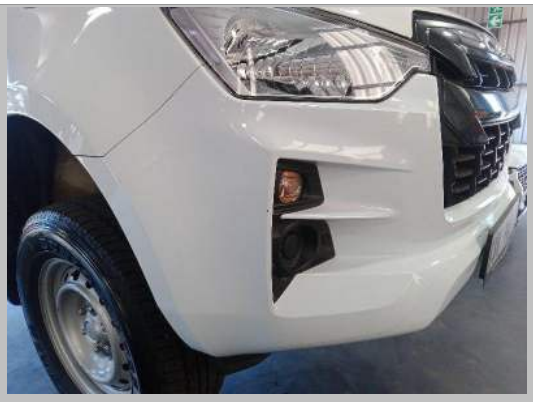
Damage	Repair Way
Seat Front Right Damaged	Repair
Front Bumper Paintwork • Chipmarks	Repair
Front Fender Right Paintwork • Scratched	Repair
Rear Fender Left Paintwork • Scratched	Repair
Rear Fender Right Paintwork • Scratched	Repair
Door Front Left Paintwork • Scratched	Repair
Door Front Right Dented	Repair
Tailgate Paintwork • Scratched	Repair
Battery warning light illuminated	Repair
