CONDITION REPORT

Report No:
2017325354
DATE
13/11/2026

Vehicle Type	PASSENGER VEHICLE	Registered Owner	
Manufacturer	CHEVROLET	Registration Number	KMP255MP
Model	SPARK 1.2 LS 5-DR [2012-2013]	Register Number	
VIN	ADMMF48DLC4627636	Date Of First Licensing	
Engine Number		Last COR	
Doors	5	License Expiry Date	
Color	BLUE	Power / Displacement	
Year Model	2012	Paint Finish	M - METALLIC
Km Reading	207,500 KM	Fuel	PETROL
Cab / Body Type	HATCHBACK	Transmission	MANUAL

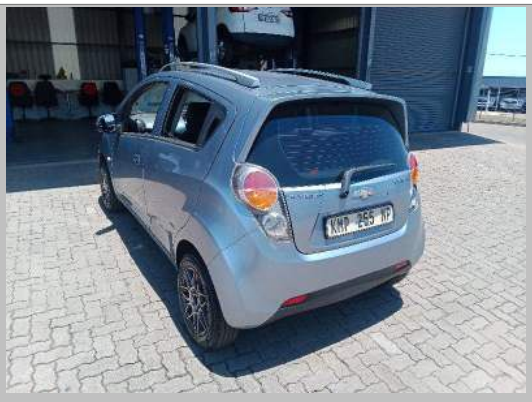
Expention bottle

Damage	Repair Way
Engine Oil Leak	Repair
Expansion Bottle Defective	Replace
Water level Insufficient	Repair
Hooter Defective	Repair
Center Console / Cubbyhole + Lid Damaged	Repair
Tail Light Right Damaged	Replace
Door Handle Front Right Malfunction	Repair
Door Handle Rear Right Malfunction	Repair
Front Bumper Paintwork • Scratched	Repair
Bonnet Paintwork • Chipmarks	Repair
Front Fender Left Paintwork • Scratched	Repair
Front Fender Right Dented	Repair
Door Front Right Paintwork • Scratched	Repair
Door Rear Right Paintwork • Scratched	Repair
Rear bumper Paintwork • Scratched	Repair
Clutch Operation Insufficient	Repair
Body exterior	Vehicle got minor scratches, stone chips and dents
Body exterior	Signs of spray work done on some body panels
Airbag light on	Repair
Brakes	No brake test done due to no clutch
Boot not opening can not see spare wheel	Repair
R/F fender liner damage	Replace
R/R tire deferred size	Repair
