CONDITION REPORT

Report No:
2017323661
DATE
10/11/2026

Vehicle Type	LIGHT LOAD VEHICLE	Registered Owner	MFC AUCTION HOUSE
Manufacturer	FORD	Registration Number	KNP595MP
Model	RANGER 2.2 TDCI XL 4X4 DSL PU [2017-2020]	Register Number	
VIN	AFANXXMJ2NJT69016	Date Of First Licensing	
Engine Number		Last COR	
Doors	2	License Expiry Date	31/05/2025
Color	WHITE	Power / Displacement	
Year Model	2018	Paint Finish	TWO COAT UNI
Km Reading	220,038 KM	Fuel	DIESEL
Cab / Body Type	SINGLE CAB	Transmission	MANUAL

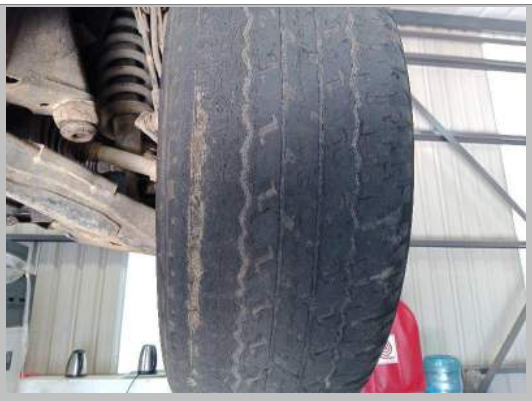
Load Body Damaged	Repair
Windscreen Cracked	Replace
Tie Rod End left Damaged	Replace
Tie Rod End right Cracked	Replace
Steering Rack Boot Left Leak	Replace
Steering Rack Boot Right Leak	Replace
Rebound Rubber Front Axle Left Damaged	Replace
Rebound Rubber Front Axle Right Damaged	Replace
Ball Joint(s) Front Axle Left Damaged	Replace
Ball Joint(s) Front Axle Right Damaged	Replace
Mounting Rubber(s) Rear Axle Left Damaged	Replace
Mounting Rubber(s) Rear Axle Right Damaged	Replace
Tyre Front Left Damaged	Replace
Tyre Front Right Damaged	Replace
Tyre Rear Left Damaged	Replace
Tyre Rear Right Damaged	Replace
Rim Front Left Dented	Repair
Rim Front Right Scratched	Repair
Bolt(s) / Nut(s) Front Wheel Right Damaged	Replace
Chassis Damaged	Repair
Engine to silencer pipe Loose / Excessive Play	Repair
Catalytic converter Missing	Replace
Belly plates Damaged	Repair
Gearbox Oil Leak	Repair
Differential Oil Leak	Repair
Radiator Cradle Damaged	Repair

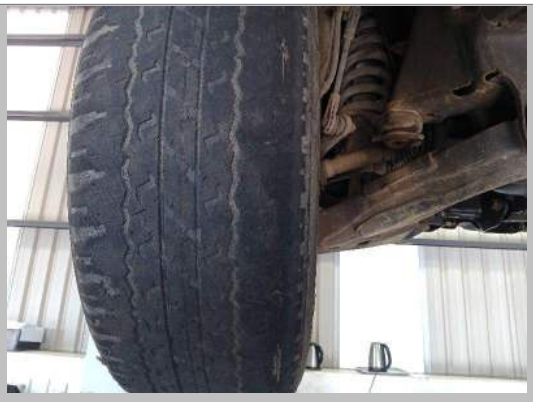
Tyre Front Right

Size	Load/Speed Index	Manufacture	Model	Type*	Production Date	Tread Depth (mm)
Front Left	265/65 R17	112T	Bridgestone	Dueler	V	4722	0 mm
Front Right	265/65 R17	112T	Bridgestone	Dueler	V	4722	0 mm
Rear Left	265/65 R17	112S	Bridgestone	Dueler	V	2218	0 mm
Rear Right	255/65 R17	110T	Goodyear	Wrangler	V	3116	0 mm
Spare	245/75 R16	111S	Jk tyre	Elanzo	V	0000	4 mm
