CONDITION REPORT

Report No:
2017318093
DATE
27/10/2026

Vehicle Type	LIGHT LOAD VEHICLE	Registered Owner	
Manufacturer	FORD	Registration Number	MB24ZWGP
Model	RANGER 2.2 TDCI XLS 4X4 DSL D-CAB PU AT [2020-2021]	Register Number	
		Date Of First Licensing	
VIN	AFAPXXMJ2PMU70617	Last COR	
Engine Number		License Expiry Date	30/06/2027
Doors	4	Power / Displacement	
Color	WHITE	Paint Finish	C - COMMON
Year Model	2021	Fuel	DIESEL
Km Reading	255,305 KM	Transmission	AUTOMATIC
Cab / Body Type	DOUBLE CAB

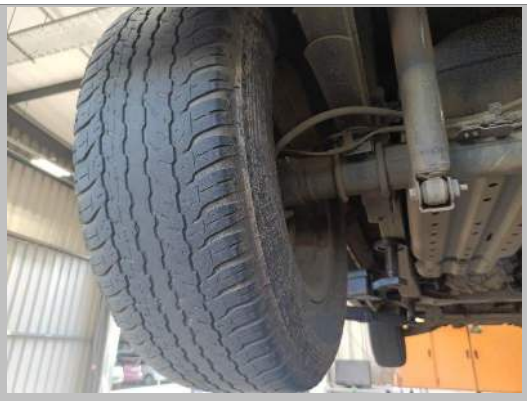
LR TYRE TREAD

Size	Load/Speed Index	Manufacture	Model	Type*	Production Date	Tread Depth (mm)
Front Left	265/65R17	112S	DUNLOP	GRANDTREK	V	2223	1 mm
Front Right	265/65R17	112S	DUNLOP	GRANDTREK	V	2821	3 mm
Rear Left	265/65R17	112S	DUNLOP	GRANDTREK	V	4828	4 mm
Rear Right	265/65R17	112S	DUNLOP	GRANDTREK	V	0000	5 mm
Spare	265/65R17	112T	CONTINENTAL	CROSS CONTAC	V	0000	7 mm

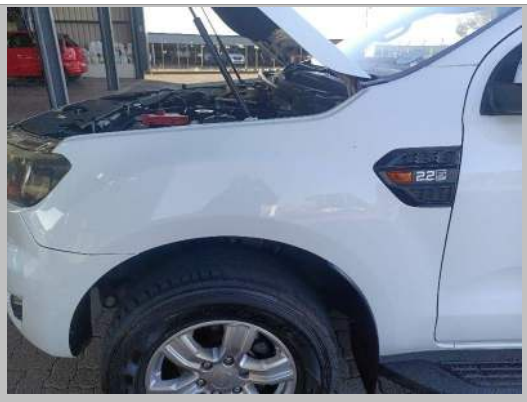
Damage	Repair Way
Engine Oil Sweat	Repair
Side Mirror Right Damaged	Replace
Front Bumper Cracked	Repair
Bonnet Paintwork • Chipmarks	Repair
Front Fender Left Paintwork • Chipmarks	Repair
Front Fender Right Residual Traces of Repair	Repair
Door Front Left Dented	Repair
Door Front Right Dented	Repair
Door Rear Left Dented	Repair
Load Body Dented	Repair
Windscreen Cracked	Replace
Gearbox Oil Sweat	Repair
BODY EXTERIOR	Minor dents scratches stone chips on some body
BODY EXTERIOR	RESIDUAL TRACES OF POOR REPAIR ON LOAD BODY NOT A
BODY EXTERIOR	Load body has traces of poor repair below standard
