CONDITION REPORT

Report No:
2017323675
DATE
11/11/2026

Vehicle Type	PASSENGER VEHICLE	Registered Owner	MFC AUCTION HOUSE
Manufacturer	TOYOTA	Registration Number	LFG539NW
Model	HI-ACE 2.5 SESFIKILE 16-S DSL MINIBUS [2024-2026]	Register Number	
		Date Of First Licensing	
VIN	AHTSS22P707162937	Last COR	
Engine Number		License Expiry Date	31/01/2027
Doors	4	Power / Displacement	
Color	WHITE	Paint Finish	C - COMMON
Year Model	2025	Fuel	DIESEL
Km Reading	101,559 KM	Transmission	MANUAL
Cab / Body Type	OTHERS

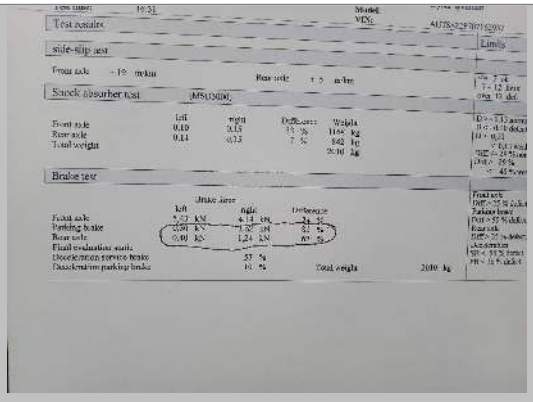
Damage	Repair Way
Caps Missing	Replace
Bonnet stay and shocks Missing	Replace
Radio/CD/USB Missing	Replace
Tail Light Left Damaged	Replace
Tail Light Right Damaged	Replace
Headlight Left Damaged	Replace
Seat Front Left Damaged	Repair
Seat Rear Damaged	Repair
Seat Rear (2. Row) Damaged	Repair
Side Mirror Left Paintwork • Scratched	Repair
Front Bumper Damaged	Repair
Bonnet Welded	Repair
Front Fender Left Dented	Repair
Rear Fender Right Dented	Repair
Door Front Left Paintwork • Scratched	Repair
Door Front Right Paintwork • Scratched	Repair
Sliding Door Residual Traces of Repair	Repair
Windscreen Chipped	Repair
Brake Drum 2. Axle left Defective	Repair
Brake Drum 2. Axle right Defective	Repair
Service Brake Performance Rear Axle Left / Right Difference out of legal range	Repair
Parking Brake Performance Left / Right Difference out of legal range	Repair
Spring Shackle Bush Rear Axle Right Missing	Replace
Tyre Front Right Smooth	Replace

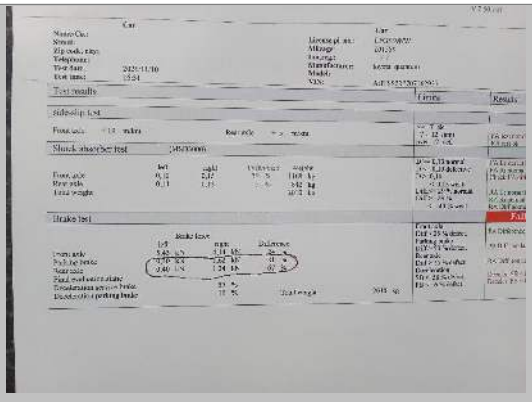
Parking Brake Performance

Left	Right		
	Braking Force [KN]	Braking Force [KN]	Axle Weight [KG]	Deceleration [m/s²]
Front	5.4	4.1	-	
Rear	0.4	1.2	-	
Emergency / Parking	0.3	1.6	-
