CONDITION REPORT

Report No:
2017257542
DATE
19/06/2026

Vehicle Type	**MINI BUS**	Registered Owner	**MFC**
Manufacturer	**TOYOTA**	Registration Number	**LH82KWGP**
Model	**HI-ACE 2.7 SESFIKILE 16-S MINIBUS [2021-2024]**	Register Number	
		Date Of First Licensing	
VIN	**AHTSX22P507112006**	Last COR	
Engine Number		License Expiry Date	**31/07/2026**
Doors	**4**	Power / Displacement	
Color	**WHITE**	Paint Finish	**C - COMMON**
Year Model	**2023**	Fuel	**PETROL**
Km Reading	**244,872 KM**	Transmission	**MANUAL**
Cab / Body Type	**OTHERS**

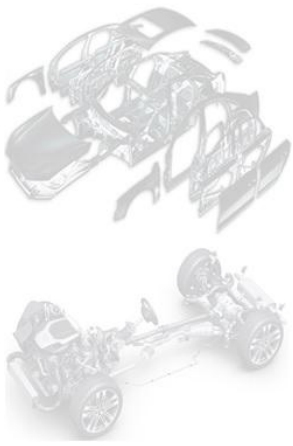
VEHICLE INSPECTION

Damage	Repair Way
Engine Wiring Defective	Repair
Seat Front Right Torn / Cut	Repair
Seat Rear Torn / Cut	Repair
Seat Rear (2. Row) Torn / Cut	Repair
Rear Fender Right Dented	Repair
Door Front Right Dented	Repair
Boot Lid / Hatch door Dented	Repair
Rear bumper Deformed	Repair
Sliding Door Dented	Repair
Tyre Rear Left Smooth	Replace
Bolt(s) / Nut(s) Front Wheel Right Missing	Replace
Engine Performance Idling / Hunting	Repair
Warning lights illuminated	Repair
Boot does not open	Repair
