CONDITION REPORT

Report No:
2017325955
DATE
16/11/2026

Vehicle Type	LIGHT LOAD VEHICLE	Registered Owner	MFC AUCTION HOUSE
Manufacturer	TOYOTA	Registration Number	HSL209MP
Model	FORTUNER 3.0 D-4D RB DSL AT [2014-2016]	Register Number	
VIN	AHTZZ69G805042969	Date Of First Licensing	
Engine Number		Last COR	
Doors	5	License Expiry Date	30/11/2026
Color	WHITE	Power / Displacement	
Year Model	2015	Paint Finish	TWO COAT METALLIC
Km Reading	332,657 KM	Fuel	DIESEL
Cab / Body Type	STATION WAGON	Transmission	AUTOMATIC

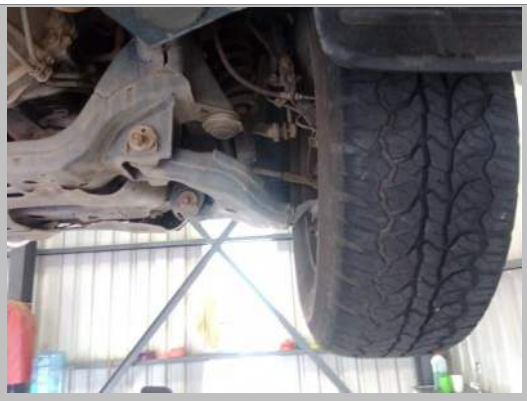
RF TYRE TREAD

Size	Load/Speed Index	Manufacture	Model	Type*	Production Date	Tread Depth (mm)
Front Left	265/65R17	112T	Goodyear	Wrangler	V	0415	3 mm
Front Right	265/65R17	110T	Lanvigator	Radial	V	4924	1 mm
Rear Left	265/65R17	110T	Lanvigator	Radial	V	4924	2 mm
Rear Right	265/65R17	110T	Lanvigator	Radial	V	4924	1 mm
Spare	265/65R17	110T	Lanvigator	Radial	V	////	1 mm

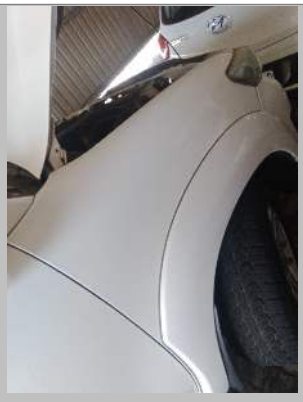
Damage	Repair Way
Engine Oil Leak	Repair
Center Console / Cubbyhole + Lid Damaged	Replace
Engine Management Lights Set	Repair
Tail Light Left Damaged	Replace
Seat Front Left Damaged	Repair
Front Bumper Damaged	Repair
Bonnet Damaged	Repair
Front Fender Left Damaged	Repair
Front Fender Right Damaged	Repair
Rear Fender Left Damaged	Repair
Rear Fender Right Damaged	Repair
Door Front Left Damaged	Repair
Door Front Right Damaged	Repair
Door Rear Left Damaged	Repair
Door Rear Right Damaged	Repair
Boot Lid / Hatch door Damaged	Replace
Rear bumper Damaged	Repair
Roof Damaged	Replace
Windscreen Damaged	Repair
