CONDITION REPORT

Report No:
2017320969
DATE
03/11/2026

MFC Auction House
M57 Pretoria Rd, Glenmarais, KEMPTON PARK
Gauteng

Vehicle Type	PASSENGER VEHICLE	Registered Owner	MFC
Manufacturer	NISSAN	Registration Number	KTG644NW
Model	X-TRAIL 2.0 VISIA 7-S [2017-2021]	Register Number	
VIN	JN1JAAT32Z0100425	Date Of First Licensing	
Engine Number		Last COR	
Doors	5	License Expiry Date	30/09/2025
Color	SILVER	Power / Displacement	
Year Model	2022	Paint Finish	TWO COAT METALLIC
Km Reading	76,852 KM	Fuel	PETROL
Cab / Body Type	SUV	Transmission	MANUAL

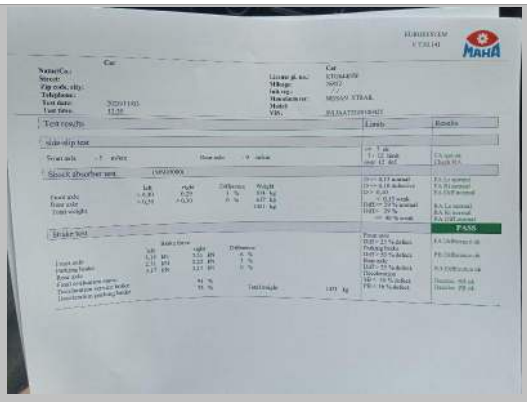
Brake test.

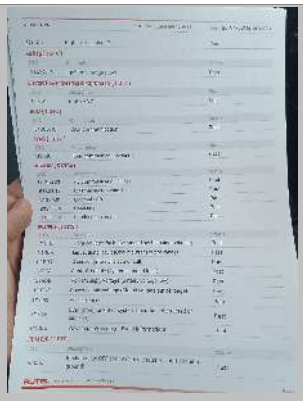
Diagnostic.

No	System	Code	Description	Status
1	ABS	C1143	STEERING ANGLE SENSOR CIRCUIT

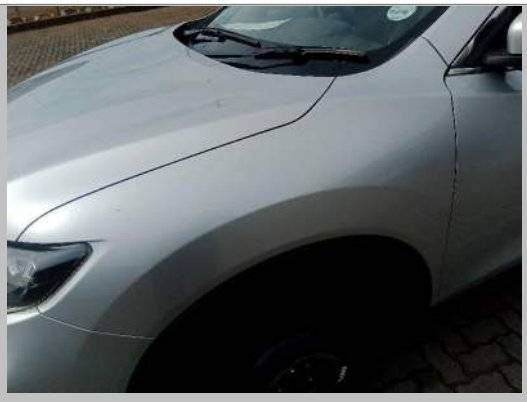
Damage	Repair Way
Engine Management Lights Set	Repair
Windscreen Wiper Damaged	Replace
Seat Front Right Damaged	Repair
Door Panel Front Right Damaged	Repair
Front Bumper Damaged	Repair
Bonnet Damaged	Repair
Front Fender Left Damaged	Repair
Front Fender Right Damaged	Repair
Rear Fender Left Damaged	Repair
Rear Fender Right Damaged	Repair
Door Front Left Damaged	Repair
Door Front Right Damaged	Repair
Door Rear Left Damaged	Repair
Door Rear Right Damaged	Repair
Boot Lid / Hatch door Damaged	Repair
Rear bumper Damaged	Repair
Inner Boot Floor Pan and Spare Wheel Well Damaged	Repair
Control Arm Bush(es) Front Axle Left Worn	Replace
Control Arm Bush(es) Front Axle Right Worn	Replace
Tyre Front Right Worn	Replace
Tyre Rear Left Worn	Replace
Spare Tyre Worn	Replace
Front tyres size differs	Replace

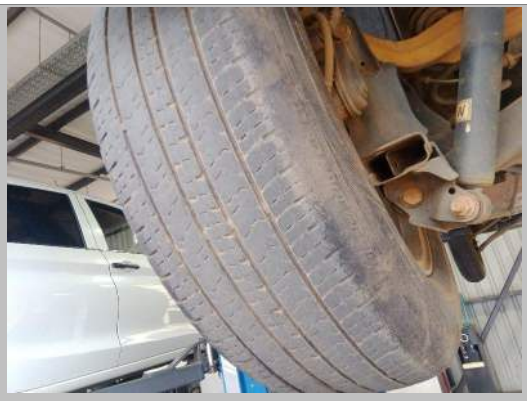
Spare Tyre

Size	Load/Speed Index	Manufacture	Model	Type*	Production Date	Tread Depth (mm)
Front Left	T155/90D17	101W	Dunlop	Temporary	V	5121	1 mm
Front Right	225/65R17	102H	Goodyear	Assurance	V	1222	0 mm
Rear Left	225/65R17	102H	Goodyear	Assurance	V	1222	0 mm
Rear Right	225/65R17	102H	Yokohama	Radial	V	0622	2 mm
Spare	225/65R17	102H	Goodyear	assurance	V	1222	0 mm

General Comments: ACCORDING TO THE AGE AND MILEAGE OF THE VEHICLE, NORMAL WEAR AND TEAR MARKS ARE VISIBLE ON THE INTERIOR, EXTERIOR, ELECTRICAL AND MECHANICAL PARTS. 25 DTC'S AT TIME OF TESTING SEE DTC REPORT.Body • Exterior: Minor dents and scratches and stone chips to body panels. Signs of repair work done to body panels. Poor alignment to somebody panels. Signs of impact damage to rear of vehicle. Repair work done to vehicle below standard. Vehicle body in poor condition. hatch door does not open.
Tyres and Rims: spare wheel deflated. front wheel sizes do not match.
