CONDITION REPORT

Report No: 2016376093

MFC Auction House
M57 Pretoria Rd, Glenmarais, KEMPTON PARK
Gauteng

Vehicle Type	**PASSENGER VEHICLE**	Registered Owner	**MFC AUCTION HOUSE**
Manufacturer	**TOYOTA**	Registration Number	**KWB730MP**
Model	**URBAN CRUISER**	Register Number	
VIN	**JTDUYMJ1S00100934**	Date Of First Licensing	
Engine Number		Last COR	
Doors	**5**	License Expiry Date	**31/05/2024**
Color	**GREY**	Power / Displacement	
Year Model		Paint Finish	**M - METALLIC**
Km Reading	**38,261 KM**	Fuel	**PETROL**
Cab / Body Type	**STATION WAGON**	Transmission	**MANUAL**

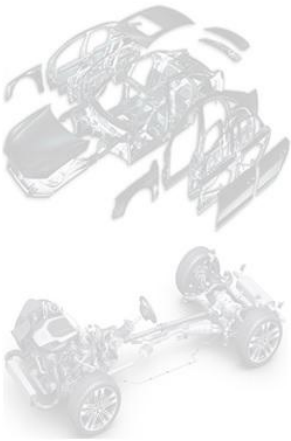
VEHICLE INSPECTION

Damage	Repair Way
Front Bumper Paintwork • Scratched	Repair
Bonnet Paintwork • Scratched	Repair
Rear Fender Right Paintwork • Scratched	Repair
Door Front Left Damaged	Repair
Door Rear Left Damaged	Repair
Door Rear Right Damaged	Repair
Rear bumper Paintwork • Scratched	Repair
Fuel Flap Damaged	Repair
Alignment Poor Alignment	Repair
Tyre Rear Left Torn / Cut	Replace
Body exterior	Signs of spray work done on some body panels
Body exterior	Minor dents scratches and stone chips on some body
Engine	Bottom of engine is covered
Undercarriage	Undercarriage is covered
