CONDITION REPORT

Report No:
2017323115
DATE
10/11/2026

Vehicle Type	PASSENGER VEHICLE	Registered Owner	MFC AUCTION HOUSE
Manufacturer	MAHINDRA	Registration Number	KGJ978MP
Model	KUV 100	Register Number	
VIN	MA1VC2RBCL6085891	Date Of First Licensing	
Engine Number		Last COR	
Doors	5	License Expiry Date	28/02/2027
Color	RED	Power / Displacement	
Year Model	2025	Paint Finish	TWO COAT METALLIC
Km Reading	80,741 KM	Fuel	PETROL
Cab / Body Type	STATION WAGON	Transmission	MANUAL

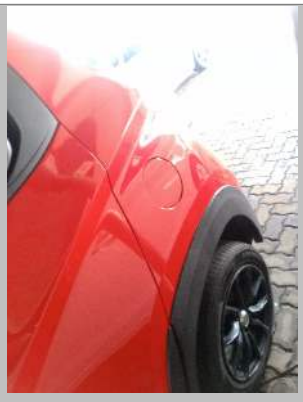
Damage	Repair Way
Central Air Vent Damaged	Replace
Radio/CD/USB Missing	Replace
Windscreen Wiper Damaged	Replace
Front Bumper Damaged	Repair
Bonnet Damaged	Repair
Front Fender Left Damaged	Repair
Rear Fender Left Damaged	Repair
Door Front Left Damaged	Repair
Door Front Right Damaged	Repair
