CONDITION REPORT

Report No:
2017323397
DATE
10/11/2026

Vehicle Type	PASSENGER VEHICLE	Registered Owner	
Manufacturer	SUZUKI	Registration Number	LDP005MP
Model	ERTIGA 1.5 GA MPV [2022-2025]	Register Number	
VIN	MA3BNC22S00826593	Date Of First Licensing	
Engine Number		Last COR	
Doors	5	License Expiry Date	
Color	SILVER	Power / Displacement	
Year Model	2024	Paint Finish	C - COMMON
Km Reading	147,015 KM	Fuel	PETROL
Cab / Body Type	STATION WAGON	Transmission	MANUAL

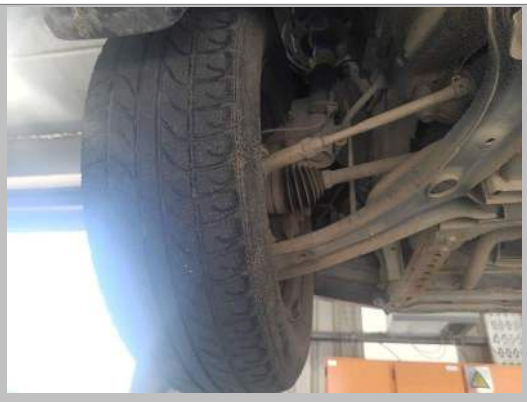
LF TYRE TREAD

Size	Load/Speed Index	Manufacture	Model	Type*	Production Date	Tread Depth (mm)
Front Left	185/65R15	88H	FIRESTONE	FIREHAWK	V	2406	1 mm
Front Right	185/65R15	88H	I LINK	L COMFORT	V	2022	1 mm
Rear Left	185/65R15	88H	BRIDGESTONE	ECOPIA	V	0422	1 mm
Rear Right	185/65R15	88H	BRIDGESTONE	ECOPIA	V	4124	1 mm
Spare	185/65R15	88H	SYMMETRY	S101	V	0000	1 mm
