CONDITION REPORT

Report No:
2017324360
DATE
11/11/2026

Vehicle Type	PASSENGER VEHICLE	Registered Owner	MFC AUCTION HOUSE
Manufacturer	HYUNDAI	Registration Number	LM79BZGP
Model	ATOS 1.1 50KW MOTION 5-DR [2019-2024]	Register Number	
VIN	MALAF51CLLM096247	Date Of First Licensing	
Engine Number		Last COR	
Doors	5	License Expiry Date	
Color	BLUE	Power / Displacement	
Year Model	2019	Paint Finish	M - METALLIC
Km Reading	221,580 KM	Fuel	PETROL
Cab / Body Type	HATCHBACK	Transmission	MANUAL

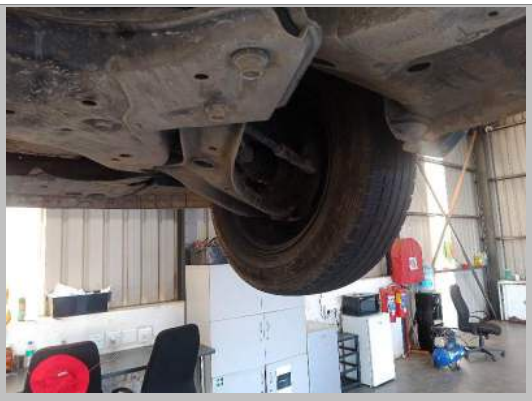
RF TYRE TREAD

Size	Load/Speed Index	Manufacture	Model	Type*	Production Date	Tread Depth (mm)
Front Left	175/65R14	82H	Sumitomo	Bc10	V	1525	3 mm
Front Right	175/65R14	82H	Sumitomo	Bc10	V	1525	3 mm
Rear Left	175/65R14	82T	Annaite	An600	V	0126	3 mm
Rear Right	175/65R14	82T	Annaite	An600	V	0126	3 mm
Spare	155/80R13	79T	Hankook	Kinergy	V	2013	3 mm

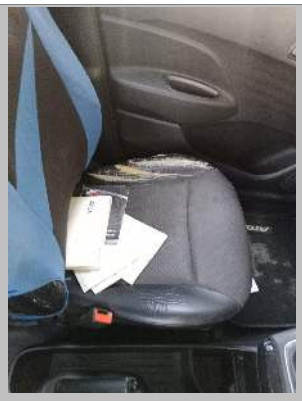
Damage	Repair Way
Water level Insufficient	Repair
Seat Front Left Torn / Cut	Repair
Seat Front Right Torn / Cut	Repair
Seat Rear Torn / Cut	Repair
Front Bumper Paintwork • Scratched	Repair
Bonnet Paintwork • Chipmarks	Repair
Front Fender Left Dented	Repair
Front Fender Right Dented	Repair
Rear Fender Left Paintwork • Scratched	Repair
Rear Fender Right Residual Traces of Repair	Repair
Door Front Left Paintwork • Scratched	Repair
Door Front Right Dented	Repair
Door Rear Left Paintwork • Scratched	Repair
Door Rear Right Dented	Repair
Boot Lid / Hatch door Dented	Repair
Rear bumper Damaged	Repair
Windscreen Cracked	Replace
Clutch Operation Slippy Hesitation	Repair
Body exterior	Vehicle got some scratches, stone chips and dents
Body exterior	Signs of spray work done on some body panels
No license disc	Replace
