CONDITION REPORT

Report No:
2017325967
DATE
16/11/2026

Vehicle Type	PASSENGER VEHICLE	Registered Owner	MFC AUCTION HOUSE
Manufacturer	HYUNDAI	Registration Number	DK84PNZN
Model	GRAND I10	Register Number	
VIN	MALB251ALTM735560	Date Of First Licensing	
Engine Number		Last COR	
Doors	5	License Expiry Date	31/03/2027
Color	WHITE	Power / Displacement	
Year Model		Paint Finish	C - COMMON
Km Reading	20,417 KM	Fuel	PETROL
Cab / Body Type	HATCHBACK	Transmission	MANUAL

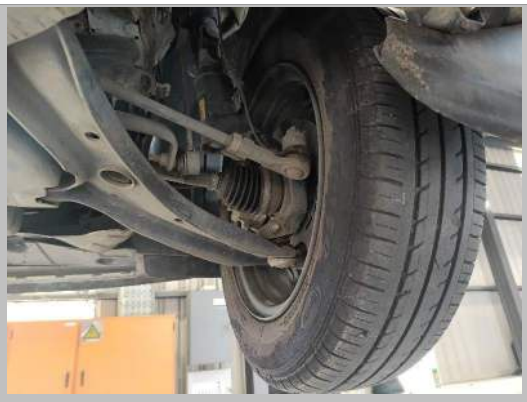
RF TYRE TREAD

Size	Load/Speed Index	Manufacture	Model	Type*	Production Date	Tread Depth (mm)
Front Left	165/70R14	81T	GOODYEAR	ASSURANCE	V	5025	2 mm
Front Right	165/70R14	81T	GOODYEAR	ASSURANCE	V	5125	2 mm
Rear Left	165/70R14	81T	GOODYEAR	ASSURANCE	V	5125	3 mm
Rear Right	165/70R14	81T	GOODYEAR	ASSURANCE	V	5125	3 mm

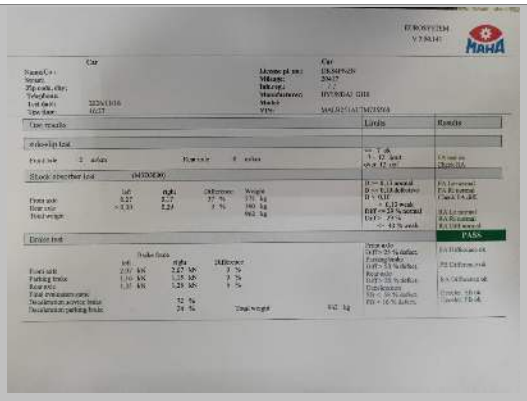
Brake report

Left	Right		
	Braking Force [KN]	Braking Force [KN]	Axle Weight [KG]	Deceleration [m/s²]
Front	2.0	2.0	-	
Rear	1.3	1.2	-	
Emergency / Parking	1.1	1.1	-

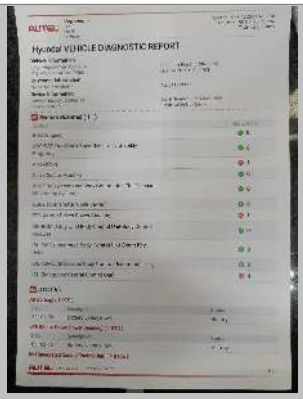
Diagnostics

No	System	Code	Description	Status
1	AB(AIRBAG)	B1102:00	BATTERY VOLTAGE LOW

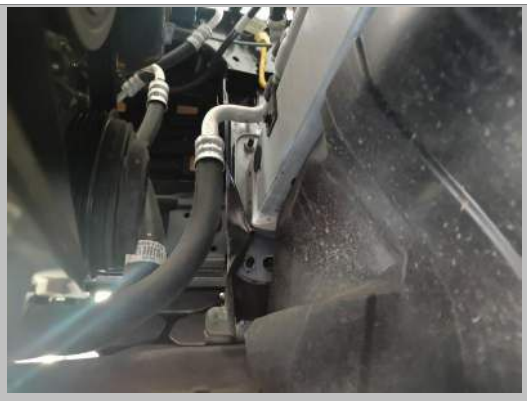
Damage	Repair Way
Engine Wiring Defective	Repair
Headlight Left Damaged	Replace
Headlight Right Scratched	Repair
Side Mirror Left Damaged	Replace
Front Bumper Damaged	Replace
Front Fender Left Damaged	Repair
Front Fender Right Dented	Repair
Rear Fender Left Dented	Repair
Rear Fender Right Damaged	Repair
Door Front Left Damaged	Repair
Door Front Right Damaged	Repair
Door Rear Left Dented	Repair
Door Rear Right Damaged	Repair
Rear bumper Damaged	Repair
Sill Panel Right Damaged	Repair
Chassis Dented	Repair
Radiator Cradle Damaged	Replace
Bumper Stiffener dented	Repair
Non standard sound system fitted	Repair
