CONDITION REPORT

Report No:
2017324296
DATE
11/11/2026

Vehicle Type	PASSENGER VEHICLE	Registered Owner	MFC
Manufacturer	SUZUKI	Registration Number	KW96SRGP
Model	DZIRE 1.2 GA MC [2020-2025]	Register Number	
VIN	MBHCZF63S00291173	Date Of First Licensing	
Engine Number		Last COR	
Doors	4	License Expiry Date	30/04/2027
Color	WHITE	Power / Displacement	
Year Model	2022	Paint Finish	TWO COAT UNI
Km Reading	132,522 KM	Fuel	PETROL
Cab / Body Type	SEDAN	Transmission	MANUAL

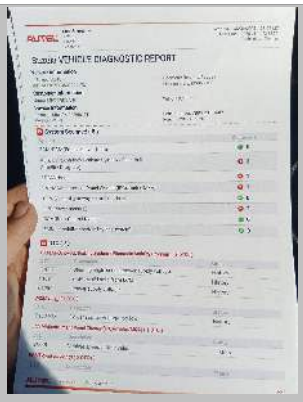
Diagnostic.

During the diagnostic no active error messages were detected. (See also attached Diagnostic Report. For more information regarding the Fault Codes (DTC) and the recommended rectifications please contact the workshops of the vehicle manufacture).
