# CONDITION REPORT

**Report No:**
**2017325956**
**DATE**
**16/11/2026**

| Manufacturer | TOYOTA | Registration Number | KZ97WJGP |
| Model | ETIOS 1.5 SPRINT [2019-2021] | Register Number | |

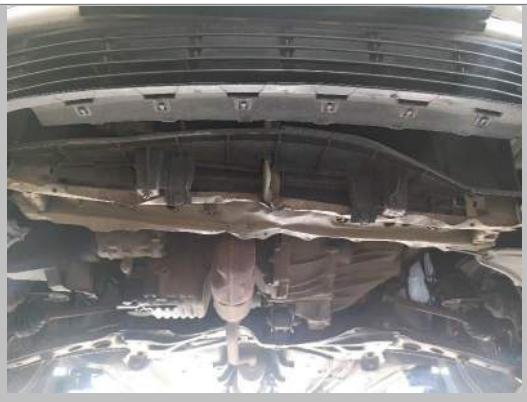
| Damage | Repair Way |
|---|---|
| Radiator Cradle Damaged | Replace |

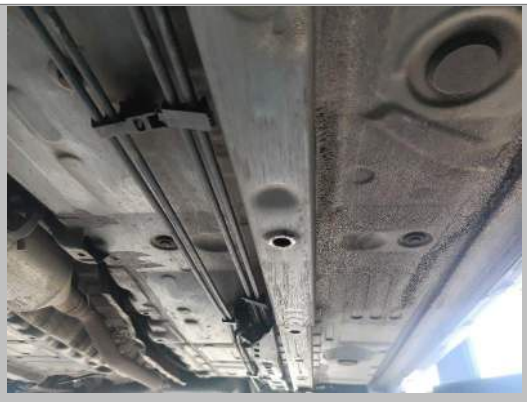
| Damage | Repair Way |
|---|---|
| Chassis Scratched | Repair |

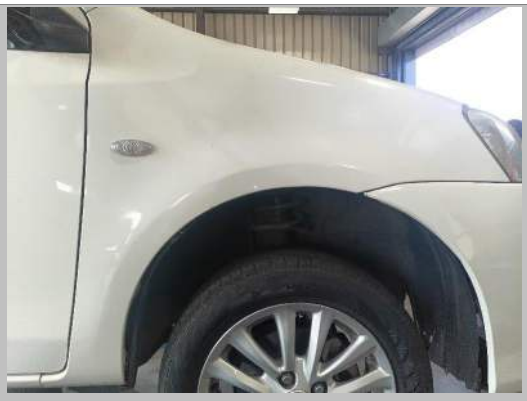
| Damage | Repair Way |
|---|---|
| Front Fender Right Paintwork • Scratched | Repair |

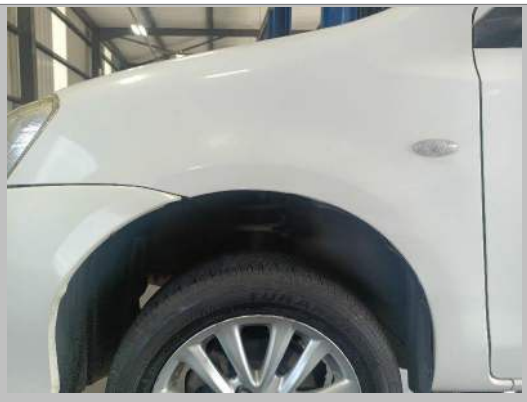
| Damage | Repair Way |
|---|---|
| Front Fender Left Dented | Repair |

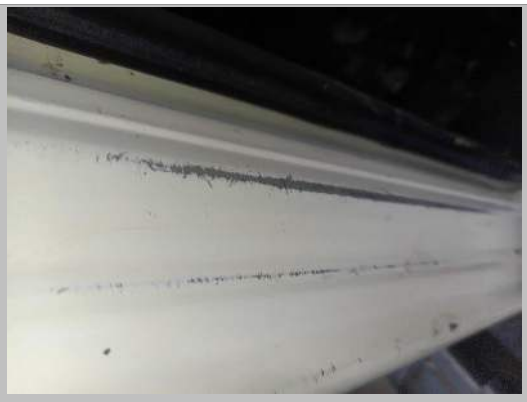
| Damage | Repair Way |
|---|---|
| Sill Panel Right Dented | Repair |

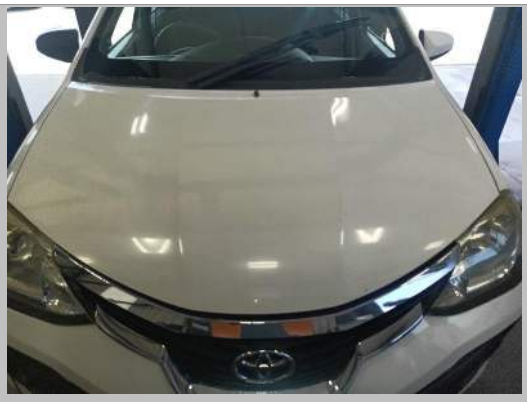
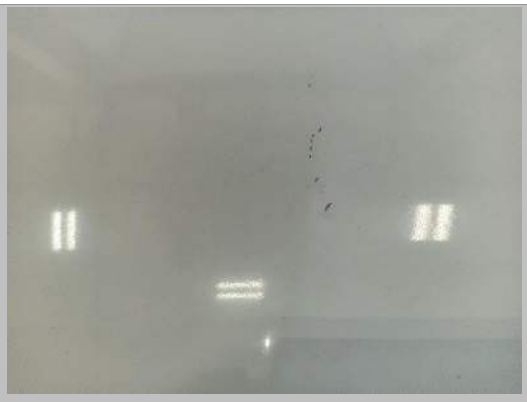
| Damage | Repair Way |
|---|---|
| Bonnet Damaged | Repair |

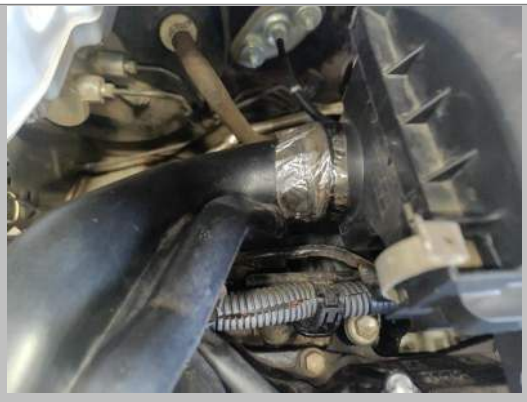
| Damage | Repair Way |
|---|---|
| Air cleaner Defective | Repair |
