CONDITION REPORT

Report No:
2017320318
DATE
02/11/2026

Vehicle Type	PASSENGER VEHICLE	Registered Owner	
Manufacturer	NISSAN	Registration Number	KD26WCGP
Model	ALMERA 1.5 ACENTA AT [2016-2024]	Register Number	
VIN	MDHBBAN17Z0724714	Date Of First Licensing	
Engine Number		Last COR	
Doors	4	License Expiry Date	
Color	WHITE	Power / Displacement	
Year Model	2018	Paint Finish	C - COMMON
Km Reading	285,044 KM	Fuel	PETROL
Cab / Body Type	SEDAN	Transmission	AUTOMATIC

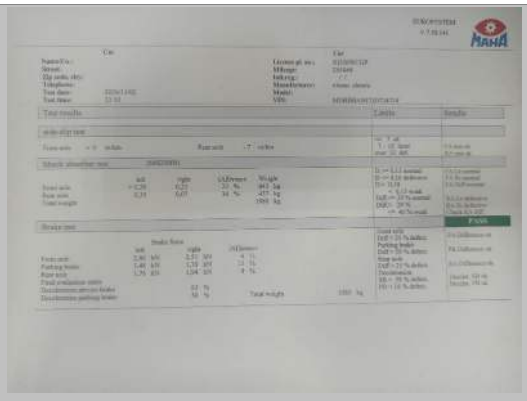
BRAKE REPORT

Left	Right		
	Braking Force [KN]	Braking Force [KN]	Axle Weight [KG]	Deceleration [m/s²]
Front	2.6	2.5	-	
Rear	1.7	1.9	-	
Emergency / Parking	1.4	1.7	-
