CONDITION REPORT

Report No:
2017326444
DATE
18/11/2026

Vehicle Type	PASSENGER VEHICLE	Registered Owner	MFC AUCTION HOUSE
Manufacturer	RENAULT	Registration Number	LY83VHGP
Model	KWID	Register Number	
VIN	MEEBBA00900856972	Date Of First Licensing	
Engine Number		Last COR	
Doors	5	License Expiry Date	30/11/2026
Color	SILVER	Power / Displacement	
Year Model		Paint Finish	M - METALLIC
Km Reading	58,239 KM	Fuel	PETROL
Cab / Body Type	HATCHBACK	Transmission	MANUAL

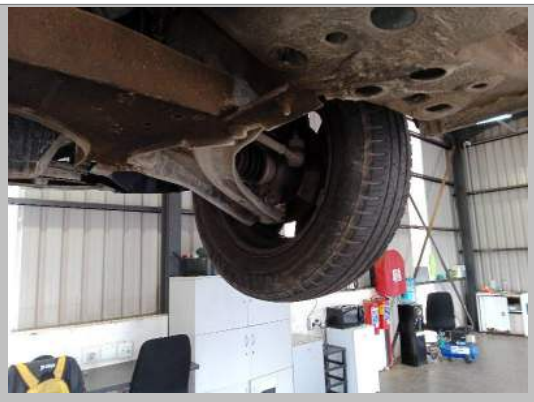
RF TYRE TREAD

Size	Load/Speed Index	Manufacture	Model	Type*	Production Date	Tread Depth (mm)
Front Left	165/70R14	81T	Ceat	Fuel smart	V	2444	3 mm
Front Right	165/70R14	81T	Ceat	Fuel smart	V	2224	2 mm
Rear Left	165/70R14	81T	Ceat	Fuel smart	V	2324	4 mm
Rear Right	165/70R14	81T	Ceat	Fuel smart	V	2324	3 mm
Spare	185/60R14	82H	Pirelli	Cinturato	V	////	2 mm
