CONDITION REPORT

Report No:
2017286405
DATE
19/08/2026

Vehicle Type	PASSENGER VEHICLE	Registered Owner	MFC
Manufacturer	RENAULT	Registration Number	N/A
Model	TRIBER	Register Number	
VIN	MEERBC00500142623	Date Of First Licensing	
Engine Number		Last COR	
Doors	5	License Expiry Date	
Color	SILVER	Power / Displacement	
Year Model		Paint Finish	TWO COAT METALLIC
Km Reading	152,304 KM	Fuel	PETROL
Cab / Body Type	STATION WAGON	Transmission	MANUAL

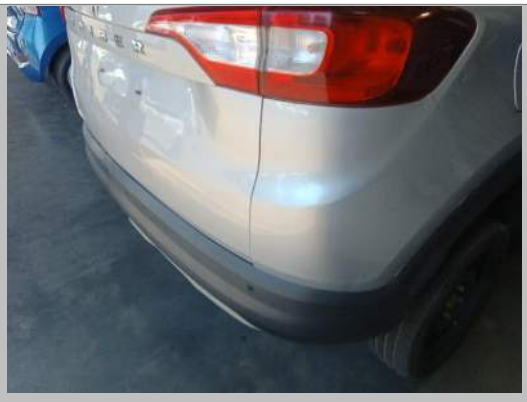
Rear Fender Left

General Comments: SIGNS OF REPAIR WORK DONE TO BODY PANELS. POOR ALIGNMENT TO SOME BODY PANELS. REPAIR WORK DONE TO VEHICLE BELOW STANDARD. VEHICLE BODY IN POOR CONDITION. ACCORDING TO THE AGE AND MILAGE OF THE VEHICLE, NORMAL WEAR AND TEAR MARKS ARE VISIBLE ON THE EXTERIOR AND INTERIOR ELECTRICAL AND MECHANICAL PARTS.

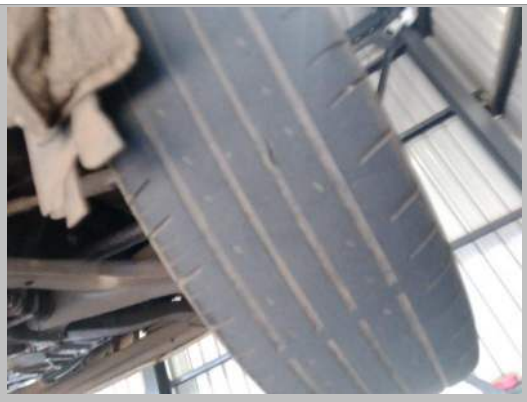
Tyre Front Left
