CONDITION REPORT

Report No:
2017323761
DATE
10/11/2026

Vehicle Type	PASSENGER VEHICLE	Registered Owner	MFC AUCTION HOUSE
Manufacturer	RENAULT	Registration Number	JX46LXGP
Model	SANDERO STEPWAY	Register Number	
VIN	VF15SRAAC64873604	Date Of First Licensing	
Engine Number		Last COR	
Doors	5	License Expiry Date	30/11/2026
Color	BROWN	Power / Displacement	
Year Model		Paint Finish	M - METALLIC
Km Reading	223,893 KM	Fuel	PETROL
Cab / Body Type	HATCHBACK	Transmission	MANUAL

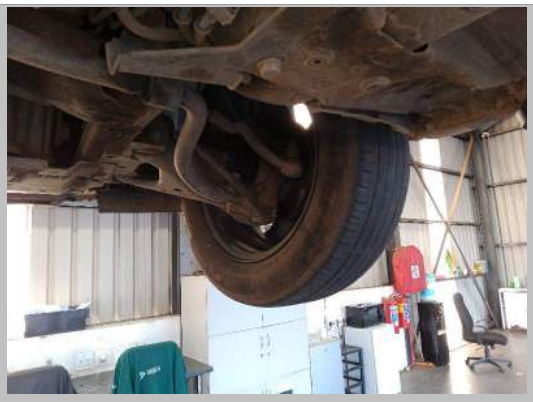
RR TYRE TREAD

Size	Load/Speed Index	Manufacture	Model	Type*	Production Date	Tread Depth (mm)
Front Left	185/65R15	92H	Dunlop	Sp sport	V	4717	3 mm
Front Right	205/55R16	91V	Continental	Contact	V	1123	3 mm
Rear Left	205/55R16	91H	Continental	Contact	V	4519	3 mm
Rear Right	205/55R16	91V	Continental	Contact	V	1123	3 mm
Spare	205/55R16	91V	Continental	Contact	V	////	2 mm

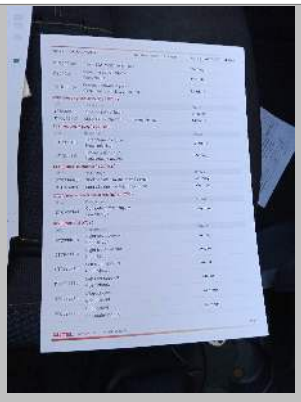
Diagnostic report

No	System	Code	Description	Status
1	MEMORY	DTC903616	POWER SUPPLY VOLTAGE

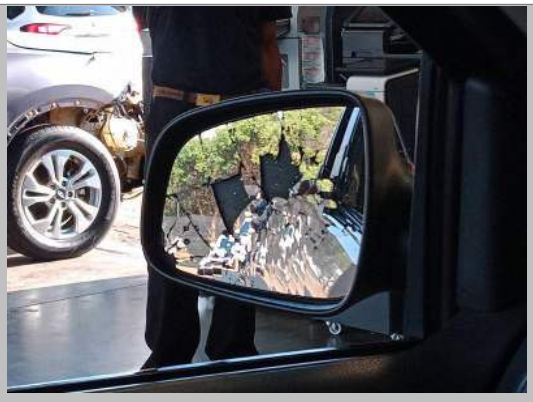
Damage	Repair Way
Tail Light Left Cracked	Replace
Tail Light Right Cracked	Repair
Side Mirror Left Damaged	Replace
Front Bumper Paintwork • Scratched	Repair
Bonnet Dented	Repair
Front Fender Left Paintwork • Scratched	Repair
Front Fender Right Dented	Repair
Rear Fender Left Dented	Repair
Rear Fender Right Dented	Repair
Door Front Left Paintwork • Scratched	Repair
Door Front Right Dented	Repair
Door Rear Left Paintwork • Scratched	Repair
Door Rear Right Paintwork • Scratched	Repair
Boot Lid / Hatch door Dented	Repair
Rear bumper Paintwork • Scratched	Repair
Windscreen Chipped	Repair
Tyre Front Left Torn / Cut	Replace
Body exterior	Vehicle got minor scratches, stone chips and dents
Front tyre size differs	Repair
