CONDITION REPORT

Report No:
2017318136
DATE
27/10/2026

MFC Auction House
M57 Pretoria Rd, Glenmarais, KEMPTON PARK
Gauteng

Vehicle Type	PASSENGER VEHICLE	Registered Owner	
Manufacturer	RENAULT	Registration Number	JX00JHGP
Model	SANDERO	Register Number	
VIN	VF15SRLA463933908	Date Of First Licensing	
Engine Number		Last COR	
Doors	5	License Expiry Date	
Color	RED	Power / Displacement	
Year Model		Paint Finish	TWO COAT UNI
Km Reading	121,408 KM	Fuel	PETROL
Cab / Body Type	HATCHBACK	Transmission	MANUAL

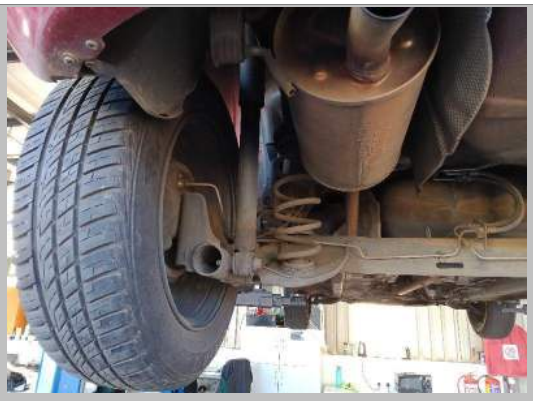
LR TYRE TREAD

Size	Load/Speed Index	Manufacture	Model	Type*	Production Date	Tread Depth (mm)
Front Left	185/65R15	88H	Tracmax	X-privilo	V	4123	0 mm
Front Right	185/65R15	88H	Tracmax	X-privilo	V	4023	0 mm
Rear Left	185/65R15	88T	Barum	Brillantis	V	3519	4 mm
Rear Right	185/65R15	88T	Continental	ContiEco	V	3319	1 mm

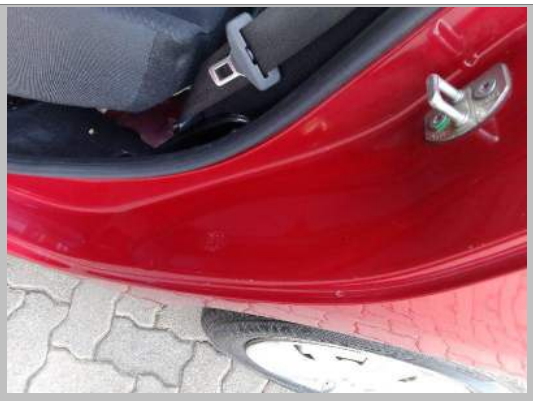
Damage	Repair Way
Air Conditioner Insufficient	Replace
Seat Rear Damaged	Repair
Front Bumper Paintwork • Scratched	Repair
Bonnet Dented	Repair
C • Pillar Left Dented	Repair
Front Fender Left Paintwork • Scratched	Repair
Front Fender Right Damaged	Repair
Rear Fender Left Dented	Repair
Rear Fender Right Damaged	Repair
Door Front Left Paintwork • Scratched	Repair
Door Front Right Paintwork • Scratched	Repair
Door Rear Left Paintwork • Scratched	Repair
Door Rear Right Dented	Repair
Boot Lid / Hatch door Dented	Repair
Sill Panel Right Dented	Repair
Windscreen Cracked	Replace
Brake disc 1. Axle left Excessive Wear & Tear	Replace
Brake disc 1. Axle right Excessive Wear & Tear	Replace
Service Brake Performance Rear Axle Left / Right Difference out of legal range	Repair
Tyre Front Left Damaged	Replace
Tyre Front Right Worn	Replace
Chassis Damaged	Repair
Belly plates Damaged	Repair
Triangle Missing	Replace
Spare wheel missing	Replace
