CONDITION REPORT

Report No:
2017234690
DATE
12/05/2026

Vehicle Type	**PASSENGER VEHICLE**	Registered Owner	**MFC**
Manufacturer	**BMW**	Registration Number	**LG64VZGP**
Model	**X4 M COMPETITION SPORT ACTIVITY COUPE AWD STEPTRONIC [2019-2022]**	Register Number	
		Date Of First Licensing	
VIN	**WBSUJ02000LC99415**	Last COR	
Engine Number		License Expiry Date	**31/10/2024**
Doors	**5**	Power / Displacement	
Color	**SILVER**	Paint Finish	**TWO COAT METALLIC**
Year Model	**2020**	Fuel	**PETROL**
Km Reading	**109,193 KM**	Transmission	**AUTOMATIC**
Cab / Body Type	**STATION WAGON**

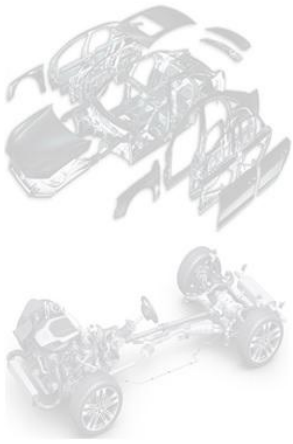
Damage	Repair Way
Bonnet stay and shocks Defective	Repair
Tail Light Left Damaged	Repair
Front Bumper Damaged	Repair
Bonnet Damaged	Repair
Front Fender Left Damaged	Repair
Front Fender Right Damaged	Repair
Rear Fender Left Damaged	Repair
Rear Fender Right Damaged	Repair
Door Front Left Damaged	Repair
Door Front Right Damaged	Repair
Door Rear Left Damaged	Repair
Door Rear Right Damaged	Repair
Boot Lid / Hatch door Damaged	Repair
Rear bumper Damaged	Repair
Windscreen Damaged	Replace
Tyre Front Left Worn	Repair
Tyre Rear Left Worn	Replace
Tyre Rear Right Worn	Repair
Airbag warning light illuminated	Repair

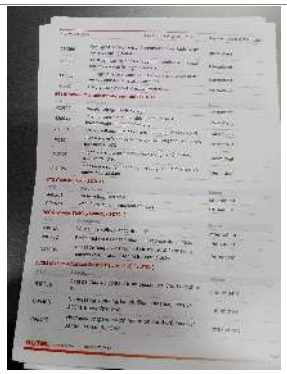
Diagnostic report

No	System	Code	Description	Status
1	VTG	CF4420	VFG, FLEXRAY: COMMUNICATION FAULT

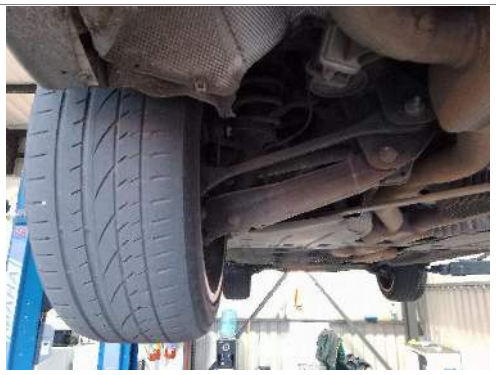
LF TYRE TREAD

Size	Load/Speed Index	Manufacture	Model	Type*	Production Date	Tread Depth (mm)
Front Left	255/40R21	102Y	Dmiax	Radial	V	0000	0 mm
Front Right	235/40R21	105Y	Continental	Crosscontact	V	0532	2 mm
Rear Left	265/40R21	105Y	Continental	Crosscontact	V	2422	0 mm
Rear Right	265/40R21	105Y	Continental	Sport	V	4622	0 mm

General Comments: ACCORDING TO THE AGE AND MILEAGE OF THE VEHICLE, NORMAL WEAR AND TEAR MARKS ARE VISIBLE ON THE INTERIOR, EXTERIOR, ELECTRICAL AND MECHANICAL PARTS.Body • Exterior: Minor dents and scratches and stone chips to some body panels. Signs of repair work done to somebody panels. Poor alignment to somebody panels.
Tyres and Rims: left front tire side wall damage.
