CONDITION REPORT

Report No:
2016984715
DATE
19/08/2025

MFC Auction House
M57 Pretoria Rd, Glenmarais, KEMPTON PARK
Gauteng

Vehicle Type	PASSENGER VEHICLE	Registered Owner	MFC
Manufacturer	MERCEDES-BENZ	Registration Number	DRJ896L
Model	C200 BLUEEFFICIENCY [2011-2014]	Register Number	
VIN	WDD2040482R200488	Date Of First Licensing	
Engine Number		Last COR	
Doors	4	License Expiry Date	31/01/2026
Color	WHITE	Power / Displacement	
Year Model	2011	Paint Finish	C - COMMON
Km Reading	297,450 KM	Fuel	PETROL
Cab / Body Type	SEDAN	Transmission	AUTOMATIC

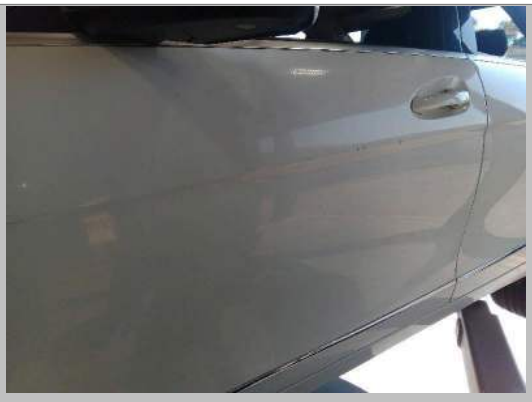
Damage	Repair Way
Engine Oil Leak	Repair
Oil level Insufficient	Repair
Seat Rear Torn / Cut	Repair
Door Handle Front Right Malfunction	Repair
Front Bumper Paintwork • Scratched	Repair
Grill Damaged	Replace
Bonnet Paintwork • Chipmarks	Repair
Front Fender Left Dented	Repair
Rear Fender Left Paintwork • Scratched	Repair
Rear Fender Right Paintwork • Scratched	Repair
Door Front Left Paintwork • Chipmarks	Repair
Door Front Right Paintwork • Scratched	Repair
Door Rear Left Paintwork • Scratched	Repair
Door Rear Right Paintwork • Scratched	Repair
Rear bumper Damaged	Repair
Sill Panel Left Paintwork • Scratched	Repair
Sill Panel Right Paintwork • Scratched	Repair
Windscreen Chipped	Repair
Control Arm Bush(es) Front Axle Left Damaged	Replace
Control Arm Bush(es) Front Axle Right Damaged	Replace
Spare Tyre Damaged	Replace
Gearbox Oil Leak	Repair
Engine light on	Repair
Rear tires deferred name brand	Repair
