## CONDITION REPORT

Report No: 2016278730

DATE  
22/02/2024

Vehicle Type	PASSENGER VEHICLE	Registered Owner	MFC AUCTION HOUSE
Manufacturer	JEEP	Registration Number	CB86ZGGP
Model	COMPASS	Register Number	
VIN	1C4NJCDAA0CD606385	Date Of First Licensing	
Engine Number		Last COR	
Doors	5	License Expiry Date	30/11/2022
Color	WHITE	Power / Displacement	
Year Model		Paint Finish	TWO COAT METALLIC
Km Reading	156,976 KM	Fuel	PETROL
Cab / Body Type	STATION WAGON	Transmission	AUTOMATIC

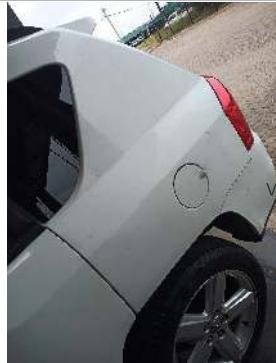
Damage	Repair Way
Engine Oil Leak	Repair
Engine Management Lights Set	Repair
Windscreen Wiper Damaged	Replace
Park Light Front Right Defective	Replace
Tail Light Right Damaged	Replace
Front Bumper Damaged	Repair
Bonnet Damaged	Repair
Front Fender Left Damaged	Repair
Front Fender Right Damaged	Repair
Rear Fender Left Damaged	Repair
Rear Fender Right Damaged	Repair
Door Front Left Damaged	Repair
Door Front Right Damaged	Repair
Door Rear Left Damaged	Repair
Door Rear Right Damaged	Repair
Boot Lid / Hatch door Damaged	Repair
Rear bumper Damaged	Repair
Shock Absorber Front Left Worn	Repair
Shock Absorber Front Right Worn	Replace
Shock Absorber Rear Left Worn	Repair
Shock Absorber Rear Right Worn	Replace
Tyre Front Left Worn	Replace
Tyre Front Right Worn	Replace
Engine Performance Insufficient	Repair
Body and exterior	Signs of repair work done to somebody panels.
Body and exterior	Minor dents and scratches and stone chips
