## CONDITION REPORT

Report No: 2016445842

MFC Auction House  
M57 Pretoria Rd, Glenmarais, KEMPTON PARK  
Gauteng

| Manufacturer | VOLKSWAGEN | Registration Number | ZLH924GP |

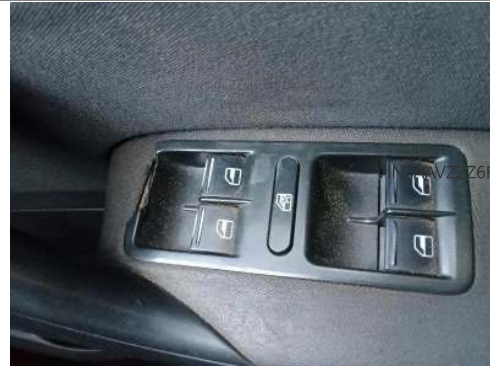
Drivers electrical switch mech

| Damage | Repair Way |
|---|---|
| Electrical instruments and components | Drivers electrical switch mechanism damaged |

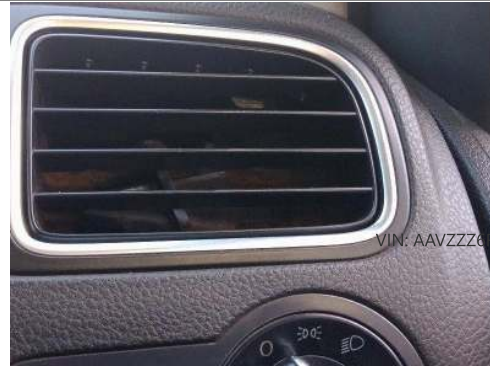
| Damage | Repair Way |
|---|---|
| Central Air Vent Damaged | Replace |
