CONDITION REPORT

Report No: 2016865442

MFC Auction House
M57 Pretoria Rd, Glenmarais, KEMPTON PARK
Gauteng

Vehicle Type	PASSENGER VEHICLE	Registered Owner	
Manufacturer	VOLKSWAGEN	Registration Number	HC84JGGP
Model	POLO GP 1.2 TSI TRENDLINE 66KW 5-DR [2016-2018]	Register Number	
VIN	AAVZZZ6RZHU109170	Date Of First Licensing	
Engine Number		Last COR	
Doors	5	License Expiry Date	31/10/2025
Color	WHITE	Power / Displacement	
Year Model	2017	Paint Finish	C - COMMON
Km Reading	107,426 KM	Fuel	PETROL
Cab / Body Type	HATCHBACK	Transmission	MANUAL

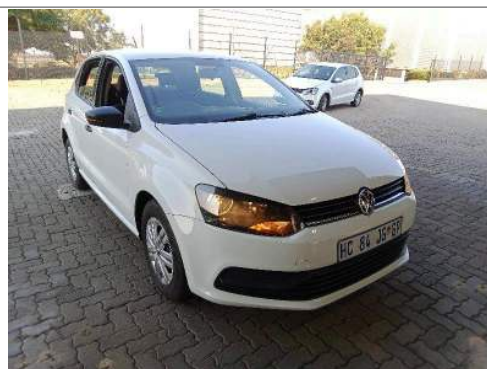
FRONT RIGHT CORNER

General Comments: ACCORDING TO THE AGE AND MILEAGE OF THE VEHICLE, NORMAL WEAR AND TEAR MARKS ARE VISIBLE ON THE INTERIOR, EXTERIOR, ELECTRICAL AND MECHANICAL PARTS. Body • Exterior: Signs of spray work done on some body panels.

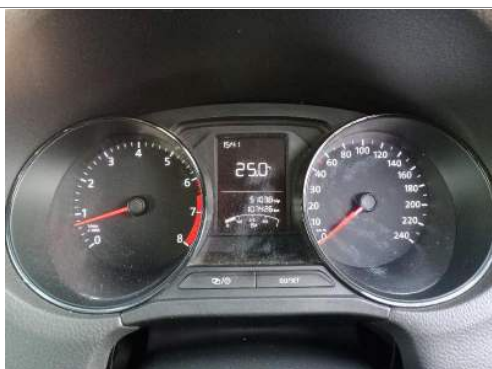
DASHBOARD (W/ ENGINE RUNNING)

Tyre Rear Right Smooth
Gearbox Oil Sweat
Engine Performance Idling / Hunting
Warning lights illuminated

Replace
Repair
Repair
Repair

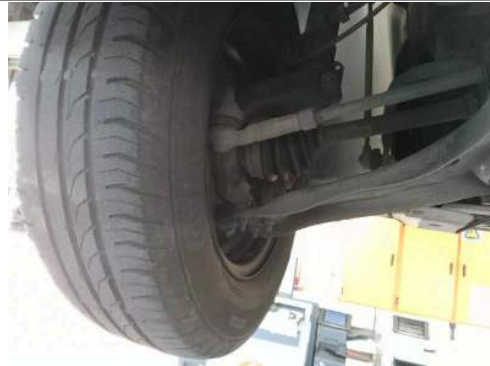
LF TYRE TREAD

Size	Load/Speed Index	Manufacture	Model	Type*	Production Date	Tread Depth (mm)
Front Left	175/70R14	84T	Continental	Control	V	3617	4 mm
Front Right	175/70R14	84T	Continental	Control	V	3617	3 mm
Rear Left	175/70R14	84T	Continental	Control	V	3617	3 mm
Rear Right	175/70R14	88T	Davanti	DX390	V	0820	0 mm
Spare	175/70R14	88T	Davanti	DX390	V	//////	1 mm
