MFC Auction House  
M57 Pretoria Rd, Glenmarais, KEMPTON PARK  
Gauteng

DEKRA MFC  
M57 Pretoria Rd - 1619  
KEMPTON PARK - GT  
08610 33572

## Assignment

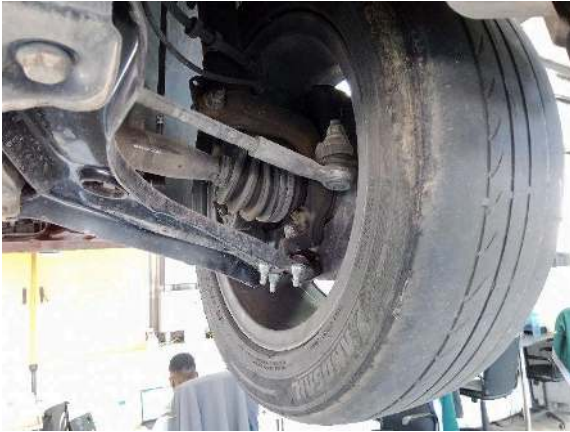
RF TYRE TREAD

| | Damage | Repair Way |
|---|---|---|
| | Tyre Front Left Smooth | Replace |
| | Tyre Front Right Smooth | Replace |

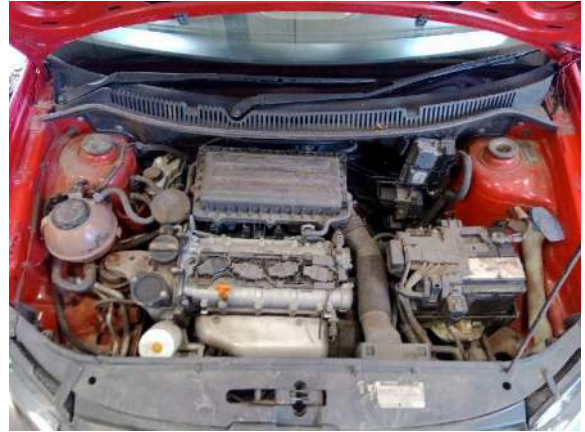
ENGINE 1

| | Damage | Repair Way |
|---|---|---|
| | Engine Leak | Repair |
| | Engine Noise Excessive | Repair |
