## CONDITION REPORT

Report No:  
2016999506  
DATE  
02/09/2025

MFC Auction House  
M57 Pretoria Rd, Glenmarais, KEMPTON PARK  
Gauteng

Vehicle Type	PASSENGER VEHICLE	Registered Owner	MFC
Manufacturer	VOLKSWAGEN	Registration Number	HVG956MP
Model	POLO VIVO GP 1.6 77KW MAXX 5-DR [2014-2016]	Register Number	
VIN	AAVZZZ6SZFU008157	Date Of First Licensing	
Engine Number		Last COR	
Doors	5	License Expiry Date	31/01/2025
Color	SILVER	Power / Displacement	
Year Model	2014	Paint Finish	TWO COAT METALLIC
Km Reading	207,985 KM	Fuel	PETROL
Cab / Body Type	HATCHBACK	Transmission	MANUAL

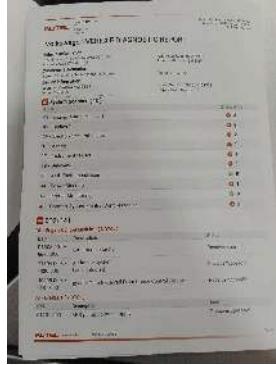
Brake test.

Left	Right	Axe Weight [KG]	Deceleration [m/s <sup>2</sup> ]
	Braking Force [KN]	Braking Force [KN]		
Front	2.39	2.63	-	
Rear	1.16	1.94	-	
Emergency / Parking	0.12	0.94	-

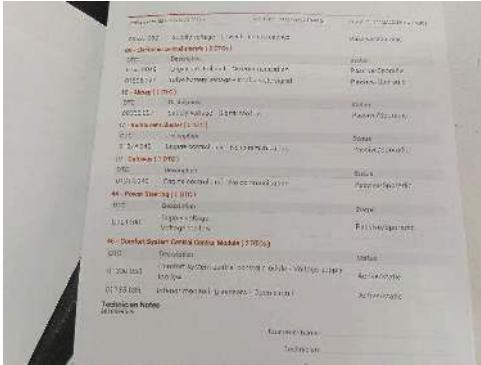
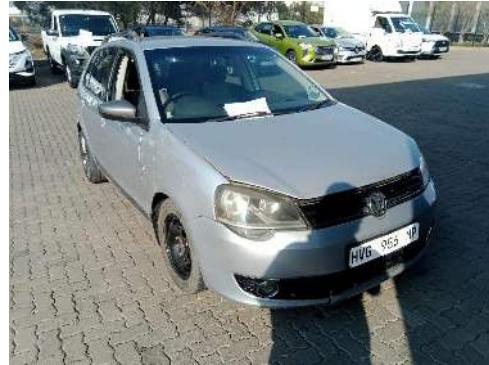
Diagnostic.

During the diagnostic no active error messages were detected. (See also attached Diagnostic Report. For more information regarding the Fault Codes (DTC) and the recommended rectifications please contact the workshops of the vehicle manufacture).

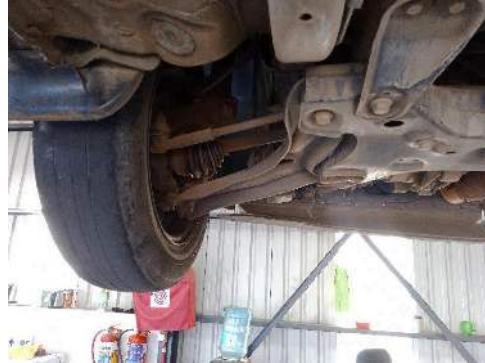
LF TYRE TREAD

Size	Load/Speed Index	Manufacture	Model	Type*	Production Date	Tread Depth (mm)
Front Left	165/70R14	81S	Bridgestone	Radial	V	3617	0 mm
Front Right	175/65R14	82T	Bridgestone	Radial	V	1516	0 mm
Rear Left	175/65R14	86H	Radar	Radial	V	1123	0 mm
Rear Right	215/40R17	87V	Continental	Contipremiu	V	2217	1 mm

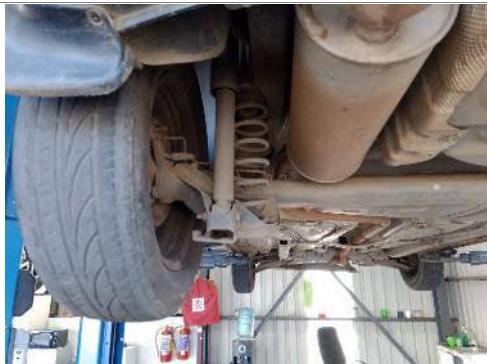
LR TYRE TREAD

Brakes: rear tire sizes do not match.

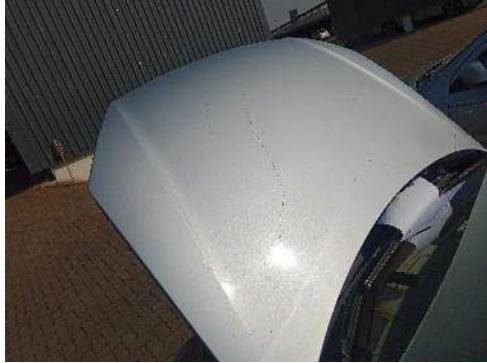
Bonnet

General Comments: ACCORDING TO THE AGE AND MILEAGE OF THE VEHICLE, NORMAL WEAR AND TEAR MARKS ARE VISIBLE ON THE INTERIOR, EXTERIOR, ELECTRICAL AND MECHANICAL PARTS. Body • Exterior: Minor dents and scratches and stone chips to some body panels. Signs of repair work done to somebody panels. Poor alignment to somebody panels. Signs of impact damage to front of vehicle.

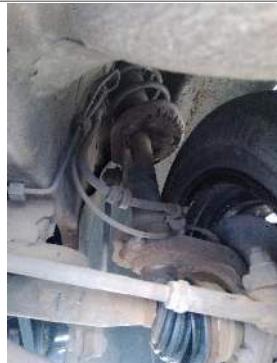
Damage	Repair Way
Engine Damaged	Replace
Hoses Damaged	Replace
Radio/CD/USB Damaged	Replace
Headlight Left Damaged	Repair
Headlight Right Damaged	Repair
Seat Front Left Damaged	Repair
Seat Front Right Damaged	Repair
Seat Rear Damaged	Repair
Sun Visor Right Damaged	Repair
Parcel Tray Damaged	Repair
Side Mirror Right Damaged	Repair
Front Bumper Damaged	Repair
Bonnet Damaged	Repair
Front Fender Left Damaged	Repair
Front Fender Right Damaged	Repair
Rear Fender Left Damaged	Repair
Rear Fender Right Damaged	Repair
Door Front Right Damaged	Repair
Door Rear Right Damaged	Repair
Boot Lid / Hatch door Damaged	Repair
Rear bumper Damaged	Repair
Shock Absorber Front Right Damaged	Replace
Tyre Front Left Worn	Replace
Tyre Front Right Worn	Replace
Tyre Rear Left Worn	Replace
Sub Frame Damaged	Repair
Engine to silencer pipe Welded	Replace
Silencer Missing	Repair
CV Joint(s) Boot(s) Front Left (inner/outer) Damaged	Replace
CV Joint(s) Boot(s) Front Right (inner/outer) Damaged	Replace
