CONDITION REPORT

Report No:  
2016904811  
DATE  
06/06/2025

| Manufacturer | VOLKSWAGEN | Registration Number | KVM657NW |
| Model | POLO VIVO GP 1.4 55KW CONCEPTLINE 5-DR [2016-2018] | Register Number | |

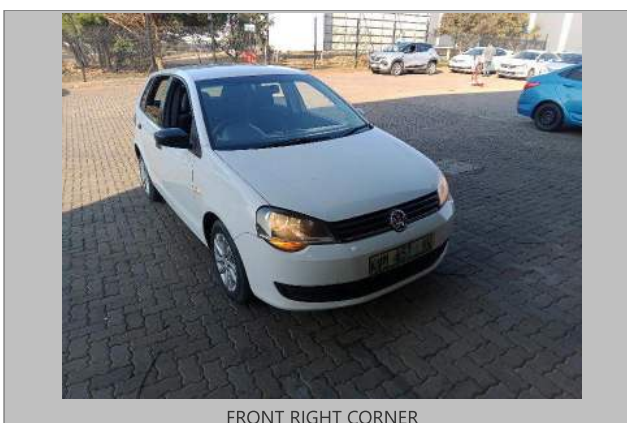
FRONT RIGHT CORNER

| Damage | Repair Way |
|---|---|
| Headlight Right Damaged | Repair |

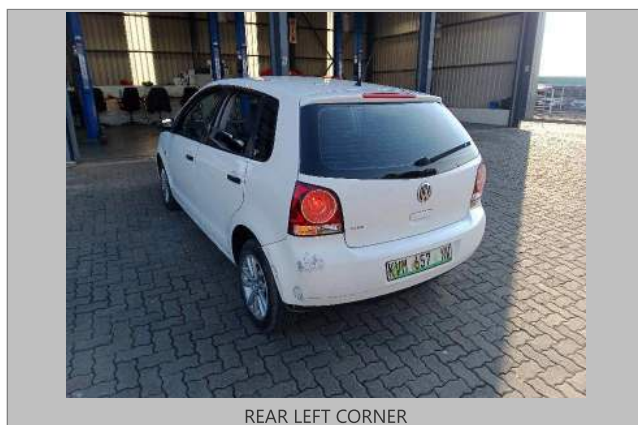
REAR LEFT CORNER

| Damage | Repair Way |
|---|---|
| Rear Fender Left Paintwork • Scratched | Repair |

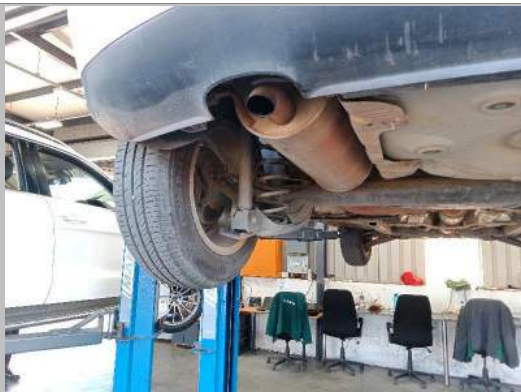
LR TYRE TREAD

| | Size | Load/Speed Index | Manufacture | Model | Type* | Production Date | Tread Depth (mm) |
|---|---|---|---|---|---|---|---|
| Rear Left | 175/65R14 | 82T | Kumho | Ecowing | V | 1622 | 3 mm |

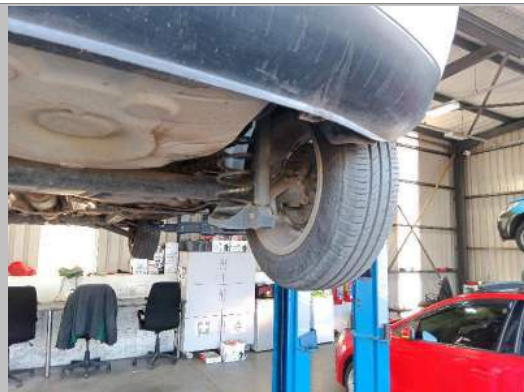
RR TYRE TREAD

| | Size | Load/Speed Index | Manufacture | Model | Type* | Production Date | Tread Depth (mm) |
|---|---|---|---|---|---|---|---|
| Rear Right | 175/65R14 | 82T | Kumho | Ecowing | V | 1622 | 3 mm |

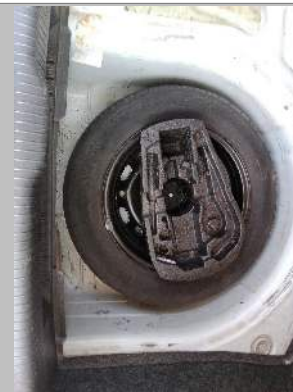
Spare wheel

| | Size | Load/Speed Index | Manufacture | Model | Type* | Production Date | Tread Depth (mm) |
|---|---|---|---|---|---|---|---|
| Spare | 175/65R14 | 82T | Goodyear | Gt2 | V | 0000 | 1 mm |
