CONDITION REPORT

Report No: 2016223324

MFC Auction House
M57 Pretoria Rd, Glenmarais, KEMPTON PARK
Gauteng

Vehicle Type	PASSENGER VEHICLE	Registered Owner	MFC
Manufacturer	VOLKSWAGEN	Registration Number	KPW468NW
Model	POLO TSI	Register Number	
VIN	AAVZZAWZJU071493	Date Of First Licensing	
Engine Number		Last COR	
Doors	5	License Expiry Date	31/01/2024
Color	GREY	Power / Displacement	
Year Model		Paint Finish	TWO COAT UNI
Km Reading	126,006 KM	Fuel	PETROL
Cab / Body Type	HATCHBACK	Transmission	MANUAL

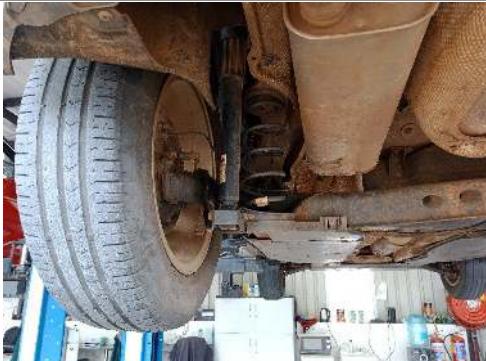
LR TYRE TREAD

Size	Load/Speed Index	Manufacture	Model	Type*	Production Date	Tread Depth (mm)
Front Left	185/65 R15	88H	Continental	Contipremium	V	1421	0 mm
Front Right	185/65 R15	88H	Continental	Contipremium	V	1421	4 mm
Rear Left	185/65 R15	88H	Continental	Contipremium	V	1421	3 mm
Rear Right	185/65 R15	88H	Continental	Contipremium	V	1421	4 mm
Spare	185/70 R14	88H	Falken	Sincera	V	3118	1 mm

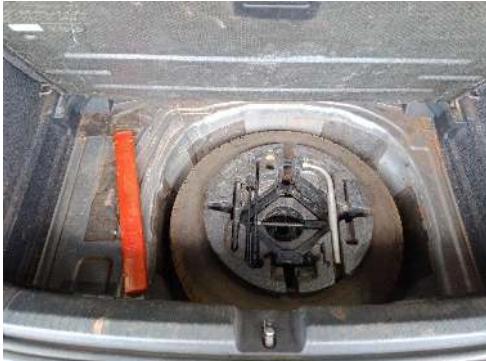
Spare wheel and Accessories

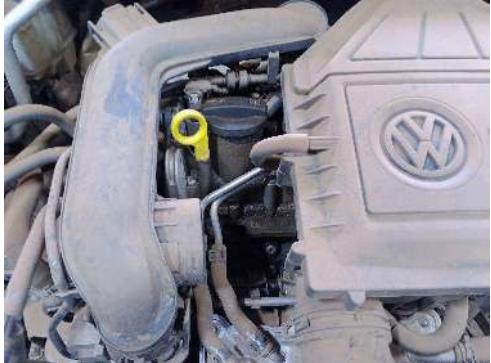
Damage	Repair Way
Engine Oil Leak	Repair
Seat Front Left Dirty	Repair
Seat Front Right Damaged	Repair
Seat Rear Dirty	Repair
Sun Visor Right Dirty	Repair
Hood Lining Defective	Repair
Side Mirror Left Paintwork • Scratched	Repair
Front Bumper Paintwork • Scratched	Repair
Bonnet Paintwork • Scratched	Repair
Front Fender Right Dented	Repair
Rear Fender Right Dented	Repair
Door Front Left Paintwork • Scratched	Repair
Door Front Right Paintwork • Scratched	Repair
Door Rear Right Paintwork • Scratched	Repair
Boot Lid / Hatch door Paintwork • Scratched	Repair
Rear bumper Paintwork • Scratched	Repair
Inner Boot Floor Pan and Spare Wheel Well Paintwork • Scratched	Repair
Rocker Panel Left Dented	Repair
Rocker Panel Right Dented	Repair
Roof Paintwork • Scratched	Repair
Windscreen Chipped	Replace
Parking Brake Performance Left / Right Difference out of legal range	Repair
Tie Rod End left Damaged	Replace
Tie Rod End right Damaged	Replace
