## CONDITION REPORT

Report No: 2016222756

MFC Auction House  
M57 Pretoria Rd, Glenmarais, KEMPTON PARK  
Gauteng

Vehicle Type	PASSENGER VEHICLE	Registered Owner	MFC
Manufacturer	VOLKSWAGEN	Registration Number	LH00VTGP
Model	POLO TSI	Register Number	
VIN	AAVZZZAWZMU056005	Date Of First Licensing	
Engine Number		Last COR	
Doors	5	License Expiry Date	31/07/2024
Color	WHITE	Power / Displacement	
Year Model		Paint Finish	TWO COAT UNI
Km Reading	62,675 KM	Fuel	PETROL
Cab / Body Type	HATCHBACK	Transmission	AUTOMATIC

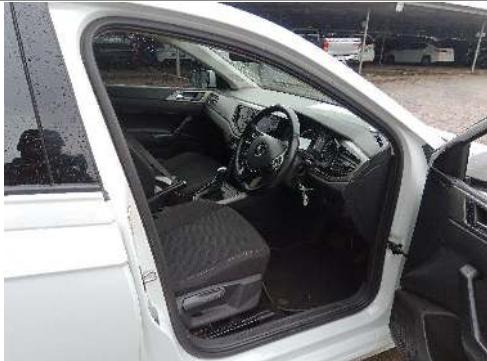
INTERIOR (FRONT DRIVER DOOR)

Interior: Vehicle interior dirty and soot

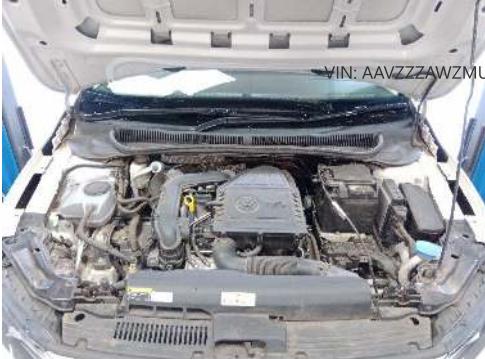
ENGINE 1

General Comments: ACCORDING TO AGE AND MILEAGE OF VEHICLE NORMAL WEAR AND TEAR ON INTERIOR, EXTERIOR, ELECTRICAL AND MECHANICAL PARTS. Engine Compartment: Engine bay dirty. Brake fluid level ok. Signs of rodent in engine bay.
