MFC Auction House  
M57 Pretoria Rd, Glenmarais, KEMPTON PARK  
Gauteng

## CONDITION REPORT

Report No: 2016209209

DATE  
21/12/2023

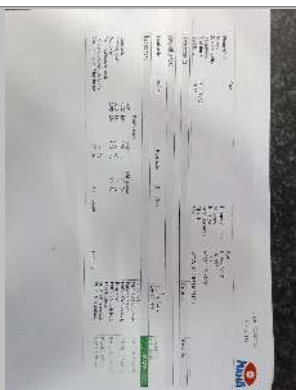
| | Left | Right | | |
|---|---|---|---|---|
| Front | 4.3 | 3.8 | - | |
| Rear | 2.9 | 3.2 | - | |
| Emergency / Parking | 3.1 | 3 | - | |

Shock and brake report

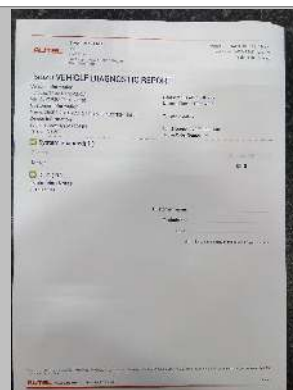
During the diagnostic no active error messages were detected. (See also attached Diagnostic Report. For more information regarding the Fault Codes (DTC) and the recommended rectifications please contact the workshops of the vehicle manufacture).

Diagnostic test

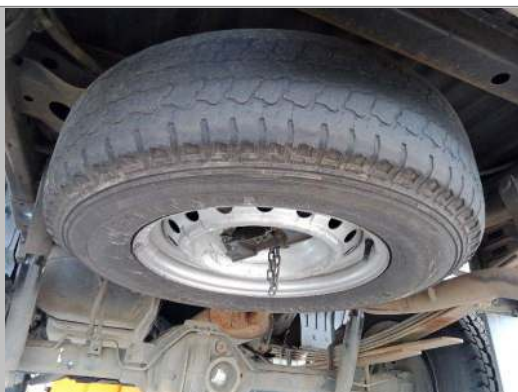
Sparewheel

| Damage | Repair Way |
|---|---|
| Spare Tyre Smooth | Replace |

| | Size | Load/Speed Index | Manufacture | Model | Type* | Production Date | Tread Depth (mm) |
|---|---|---|---|---|---|---|---|
| Spare | 205R16 | 110/108T | Continental | Contact | V | 0000 | 0 mm |

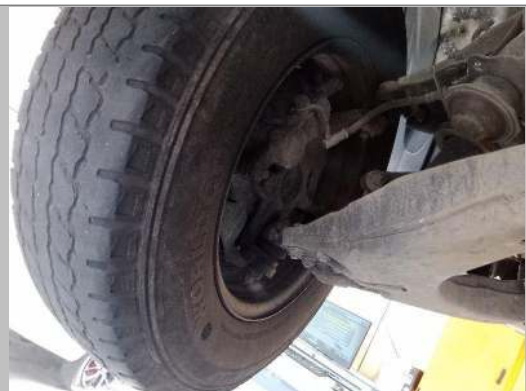
LF TYRE TREAD

| | Size | Load/Speed Index | Manufacture | Model | Type* | Production Date | Tread Depth (mm) |
|---|---|---|---|---|---|---|---|
| Front Left | 205R16 | 110/108S | Continental | Contact | V | 1821 | 1 mm |

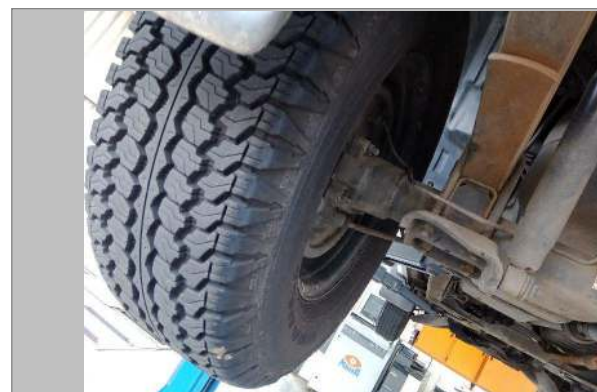
LR TYRE TREAD

| | Size | Load/Speed Index | Manufacture | Model | Type* | Production Date | Tread Depth (mm) |
|---|---|---|---|---|---|---|---|
| Rear Left | 245/70R16 | 111/109T | Goodyear | Wrangler | V | 0819 | 7 mm |

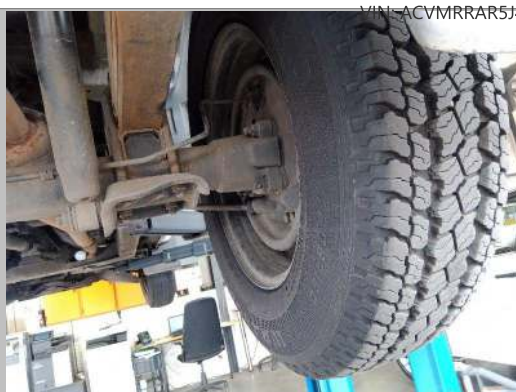
RR TYRE TREAD

| | Size | Load/Speed Index | Manufacture | Model | Type* | Production Date | Tread Depth (mm) |
|---|---|---|---|---|---|---|---|
| Rear Right | 245/70R16 | 111/109T | Goodyear | Wrangler | V | 2923 | 6 mm |
