MFC Auction House  
M57 Pretoria Rd, Glenmarais, KEMPTON PARK  
Gauteng

| Manufacturer | ISUZU | Registration Number | KMK001NW |

## CONDITION REPORT

Report No: 2016309496

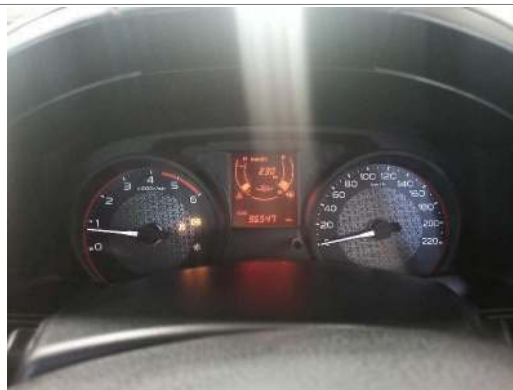
DASHBOARD (W/ ENGINE RUNNING)

| Damage | Repair Way |
|---|---|
| Engine Management Lights Set | Repair |

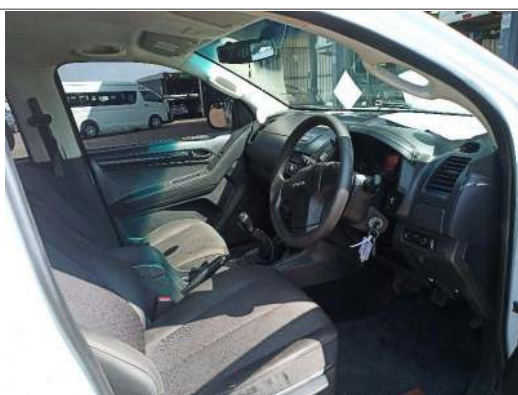
INTERIOR (FRONT DRIVER DOOR)

| Damage | Repair Way |
|---|---|
| Seat Front Right Worn | Repair |

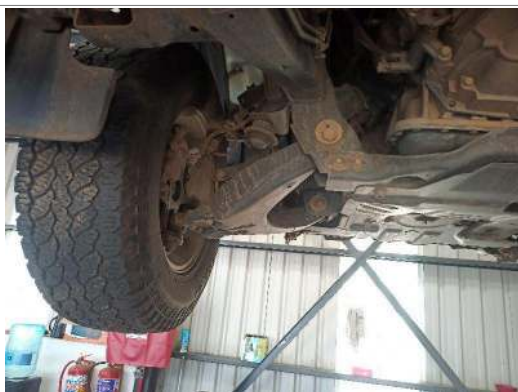
LF TYRE TREAD

| | Size | Load/Speed Index | Manufacture | Model | Type* | Production Date | Tread Depth (mm) |
|---|---|---|---|---|---|---|---|
| Front Left | 245/70R16 | 111H | General | Radial | V | 4421 | 1 mm |

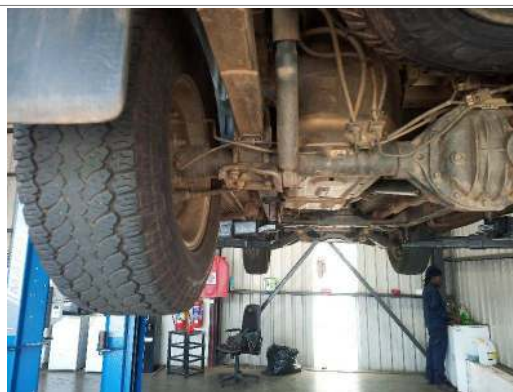
LR TYRE TREAD

| | Size | Load/Speed Index | Manufacture | Model | Type* | Production Date | Tread Depth (mm) |
|---|---|---|---|---|---|---|---|
| Rear Left | 245/70R16 | 111H | General | Radial | V | 5021 | 1 mm |

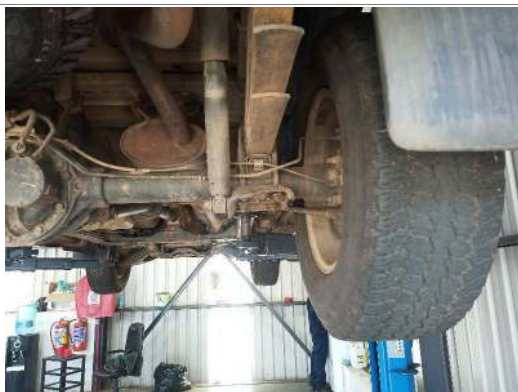
RR TYRE TREAD

| | Size | Load/Speed Index | Manufacture | Model | Type* | Production Date | Tread Depth (mm) |
|---|---|---|---|---|---|---|---|
| Rear Right | 245/70R16 | 111T | Goodyear | Wrangler | V | 0421 | 1 mm |
