CONDITION REPORT

Report No: 2016232602

DATE
18/01/2024

Vehicle Type	LIGHT LOAD VEHICLE	Registered Owner	MFC AUCTION HOUSE
Manufacturer	NISSAN	Registration Number	FK48JCGP
Model	NP300 HARDBODY	Register Number	
VIN	ADNCDGD22ZR088423	Date Of First Licensing	
Engine Number		Last COR	
Doors	4	License Expiry Date	31/01/2024
Color	WHITE	Power / Displacement	
Year Model		Paint Finish	TWO COAT METALLIC
Km Reading	161,494 KM	Fuel	PETROL
Cab / Body Type	DOUBLE CAB	Transmission	MANUAL

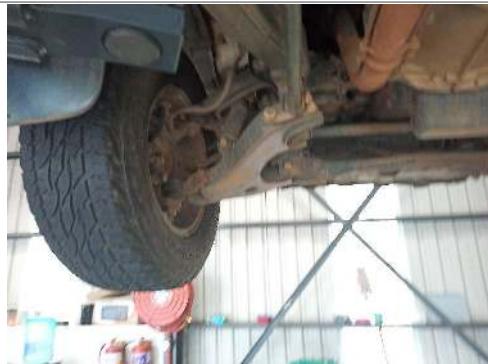
LF TYRE TREAD

Size	Load/Speed Index	Manufacture	Model	Type*	Production Date	Tread Depth (mm)
Front Left	245/70R16	107S	Bridgestone	Radial	V	3319	2 mm
Front Right	245/70R16	107S	Bridgestone	Radial	V	3219	2 mm
Rear Left	245/70R16	107S	Bridgestone	Radial	V	3319	2 mm
Rear Right	245/70R16	107S	Bridgestone	Radial	V	3319	2 mm

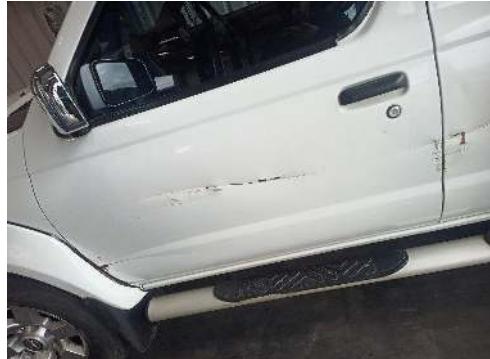
Door Front Left

General Comments: ACCORDING TO THE AGE AND MILEAGE OF THE VEHICLE, NORMAL WEAR AND TEAR MARKS ARE VISIBLE ON THE INTERIOR, EXTERIOR, ELECTRICAL AND MECHANICAL PARTS. Interior: Sound wiring loose in vehicle
 Body • Exterior: Minor dents and scratches and stone chip
