## CONDITION REPORT

Report No: 2016272800

MFC Auction House  
M57 Pretoria Rd, Glenmarais, KEMPTON PARK  
Gauteng

| Manufacturer | NISSAN | Registration Number | JR23PWGP |

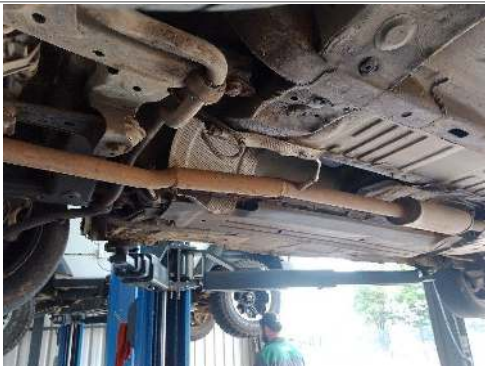
| Damage | Repair Way |
|---|---|
| Engine to silencer pipe Defective | Repair |
