CONDITION REPORT

Report No: 2016879026

Vehicle Type	LIGHT LOAD VEHICLE	Registered Owner	
Manufacturer	NISSAN	Registration Number	HX25YJGP
Model	NP200 1.5DCI BASE +AC SAFETY DSL PU [2014-2022]	Register Number	
VIN	ADNUSN365U0160767	Date Of First Licensing	
Engine Number		Last COR	
Doors	2	License Expiry Date	
Color	WHITE	Power / Displacement	
Year Model	2019	Paint Finish	C - COMMON
Km Reading	237,246 KM	Fuel	DIESEL
Cab / Body Type	SINGLE CAB	Transmission	MANUAL

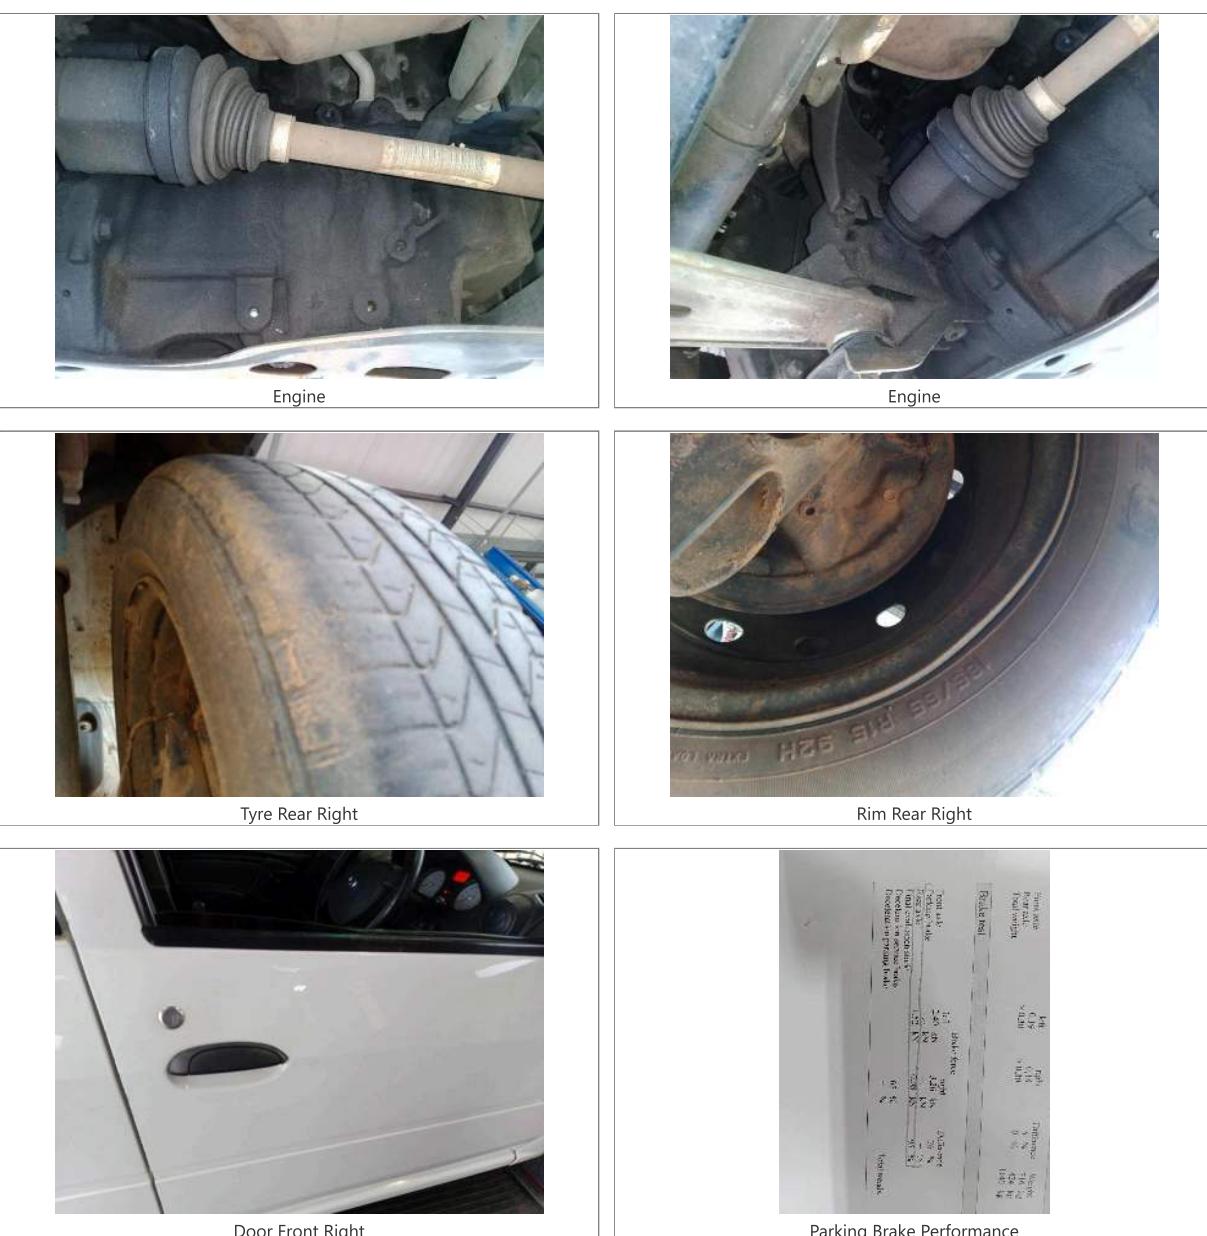
Parking Brake Performance

Left	Right	Axle Weight [KG]	Deceleration [m/s ²]
	Braking Force [KN]	Braking Force [KN]		
Front	2.4	3.2	-	
Rear	1.5	0.0	-	
Emergency / Parking	0	0	-
