MFC Auction House  
M57 Pretoria Rd, Glenmarais, KEMPTON PARK  
Gauteng

DEKRA MFC  
M57 Pretoria Rd - 1619  
KEMPTON PARK - GT  
08610 33572

| Manufacturer | NISSAN | Registration Number | KSN522MP |

Report No: 2016221031

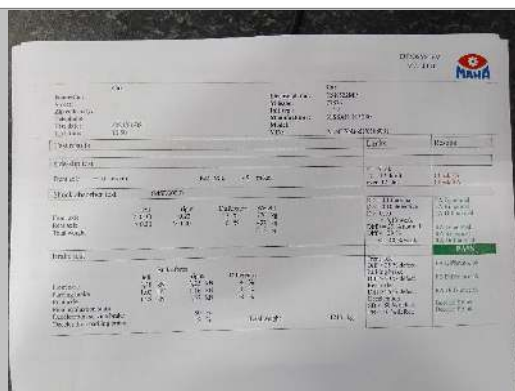
Shock and brake report

| Damage | Repair Way |
|---|---|
| Shock Absorber Rear Right Sweat | Replace |

| | Left | Right | | |
|---|---|---|---|---|
| Front | 3.3 | 3.2 | - | |
| Rear | 1.2 | 1.5 | - | |
| Emergency / Parking | 1 | 1.1 | - | |

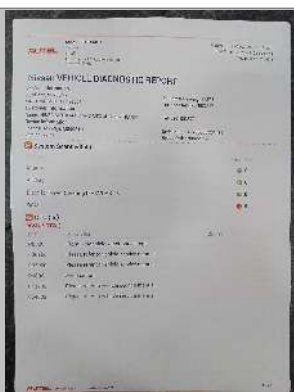
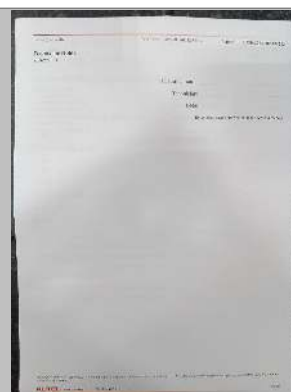
Diagnostic test

During the diagnostic no active error messages were detected. (See also attached Diagnostic Report. For more information regarding the Fault Codes (DTC) and the recommended rectifications please contact the workshops of the vehicle manufacture).

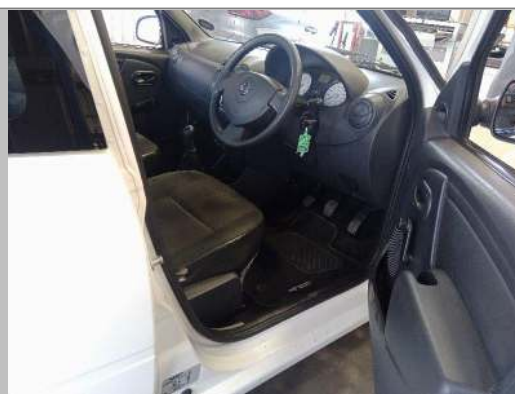
INTERIOR (FRONT DRIVER DOOR)

| Damage | Repair Way |
|---|---|
| Seat Front Right Torn / Cut | Repair |

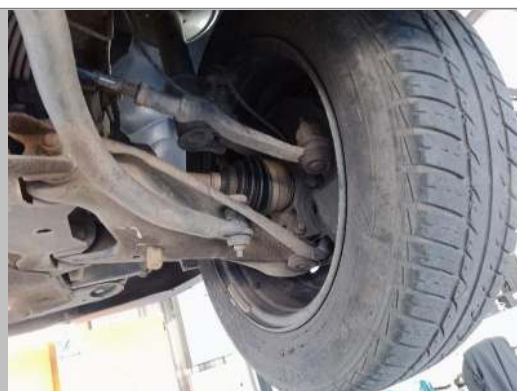
RF TYRE TREAD

| Damage | Repair Way |
|---|---|
| Tyre Front Right Damaged | Replace |

| | Size | Load/Speed Index | Manufacture | Model | Type* | Production Date | Tread Depth (mm) |
|---|---|---|---|---|---|---|---|
| Front Right | 185/65R15 | 92T | Barum | Brilliantis | V | 4820 | 5 mm |
