CONDITION REPORT

Report No: 2016207091

Vehicle Type	LIGHT LOAD VEHICLE	Registered Owner	MFC
Manufacturer	FORD	Registration Number	HNL870FS
Model	RANGER	Register Number	
VIN	AFAGXXMJ2GHU44411	Date Of First Licensing	
Engine Number		Last COR	
Doors	2	License Expiry Date	31/12/2023
Color	WHITE	Power / Displacement	
Year Model		Paint Finish	C - COMMON
Km Reading	211,942 KM	Fuel	DIESEL
Cab / Body Type	SUPER CAB	Transmission	MANUAL

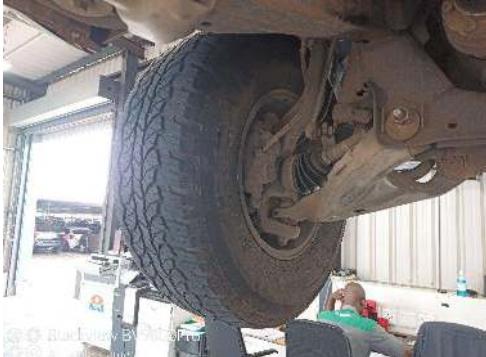
LF TYRE TREAD

Size	Load/Speed Index	Manufacture	Model	Type*	Production Date	Tread Depth (mm)
Front Left	275/70R16	114T	Lanigator	Catchfors	V	1821	3 mm
Front Right	275/70R16	114T	Lanigator	Catchfors	V	1821	3 mm
Rear Left	275/70R16	114T	Lanigator	Catchfors	V	1821	4 mm
Rear Right	275/70R16	114T	Lanigator	Catchfors	V	1821	4 mm
Spare	215R15	109/107S	Dunlop	Sp sport	V	1317	1 mm

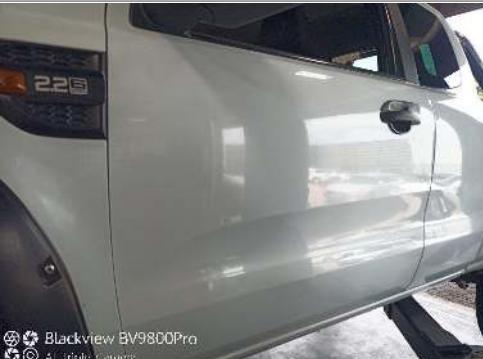
Door Front Left

Body • Exterior: Vehicle got minor scratches, stone chips and dents on some body panels
